TOWN OF RYE, NEW HAMPSHIRE

Existing Building Assessment January 2014

Prepared by:
Sheerr McCrystal Palson Architecture, Inc.
Concord, New Hampshire
www.sheerr.com

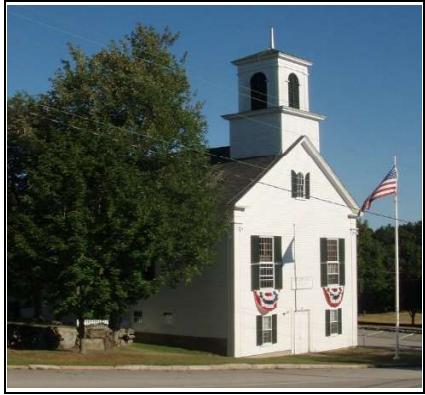
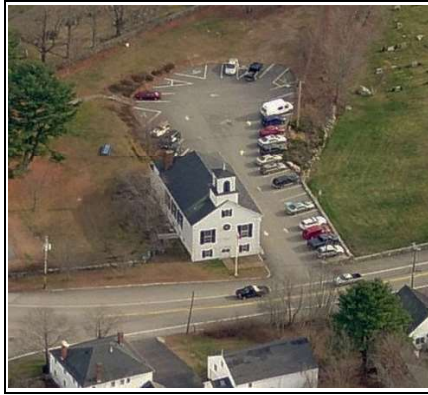
Property: Town Hall Date of Review: Jan 2014

General Code Compliance: Use Group B, proposed Use Group A3 (Assembly). Deficiencies in emergency egress, accessibility, fire separation, energy efficiency (shell), plumbing code. Underground fuel tank.

Comments: While the Town Hall structure appears to be serviceable into the future, its current use as a public facility and proposed use to return it to assembly/mixed use space require significant upgrades. Many of these would be necessary even if the current use remained unchanged.

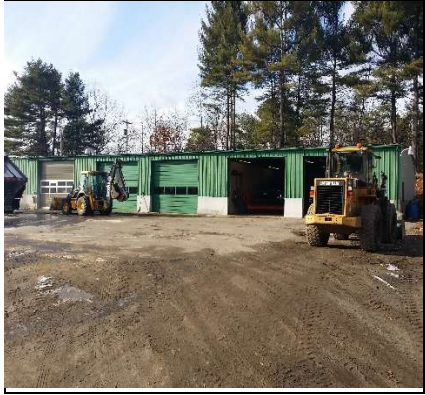
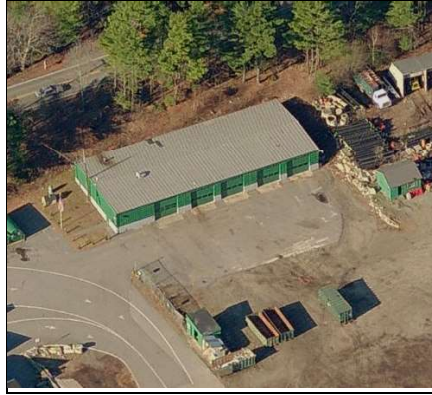
Property: Highway Garage Date of Review: Jan 2014
Address: 309 Grove Street Tax Map/Lot: 11/134
Year Built: 1981 Initial Cost: \$250,000 Maintained by: Public Works

General Code Compliance: Use Group S-1: Requirements for lifesafety in the facility appear to be met. Wood framing at offices may not be allowable in this construction type.

Comments: Building is part ongoing facility evaluation by Weston and Sampson Engineers therefore our conditions assessment has been limited to a brief walk-through. Overall condition of the facility is generally fair to poor. Building seems to meet the minimal functional requirements for the dept.

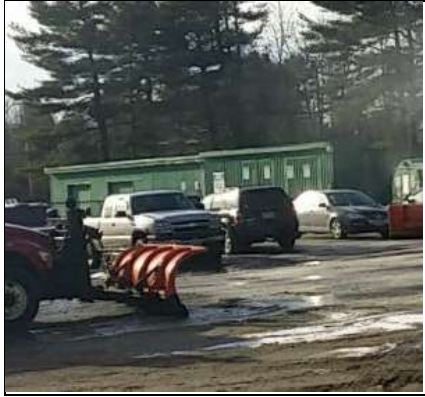
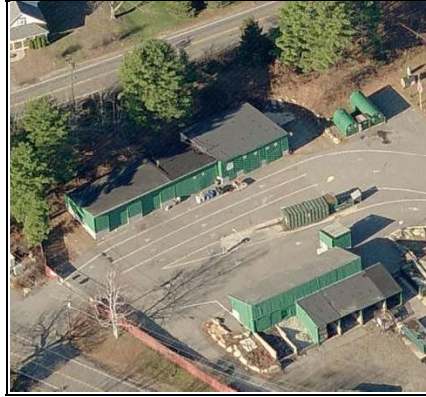
Property: Recycling Date of Review: Jan 2014

Siding: Wood, Board & Batten Year Installed: 1984 Cost: _____ Condition: Poor

General Code Compliance: Use Group F-1: Building appears to meet the minimal requirements for lifesafety. Since equipment operates inside the building a ventilation system may be required;

Comments: Building is part ongoing facility evaluation by Weston and Sampson Engineers therefore our conditions assessment has been limited to a brief walk-through. Overall condition of the building is fair and serviceable. Facility size seems small to meet the functional demands efficiently.

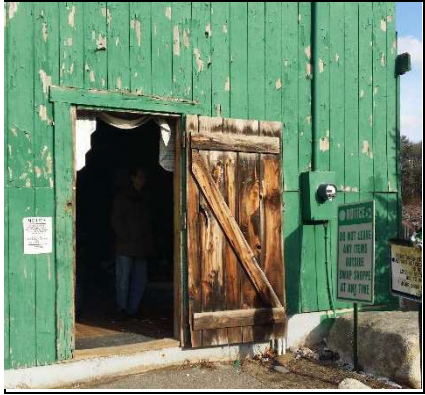
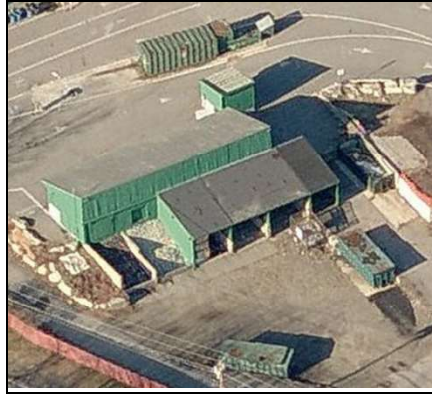
Property: Swap Shop Date of Review: Jan 2014

Roof: Tab shingle Year Installed: 1984 Cost: _____ Condition: Poor

Siding: Wood, T-111 Year Installed: _____ Cost: _____ Condition: Poor

Comments: Building is part of an ongoing facility evaluation by Weston and Sampson Engineers therefore our conditions assessment has been limited to a brief walk-through. Overall condition of the building is fair; siding requires attention. Facility storage size seems small, though may be adequate for the proposed use.

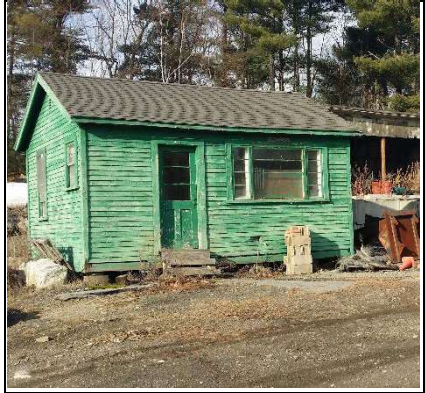
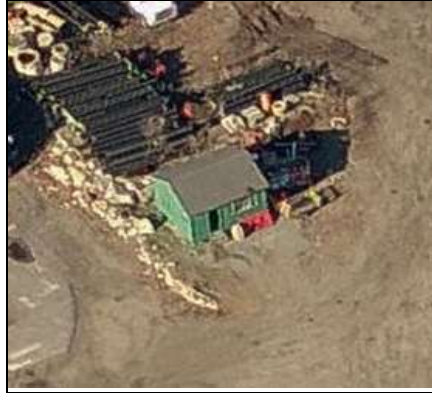
Property: Sign Shed Date of Review: Jan 2014

Comments: Building is part of an ongoing facility evaluation by Weston and Sampson Engineers therefore our conditions assessment has been limited to a brief walk-through. Overall condition of the building is fair and serviceable; siding and roofing require attention. Facility storage size seems adequate to meet the needs of the town.

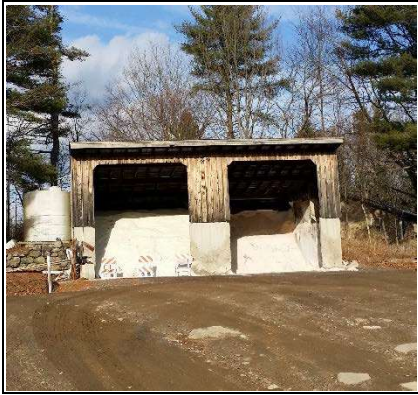
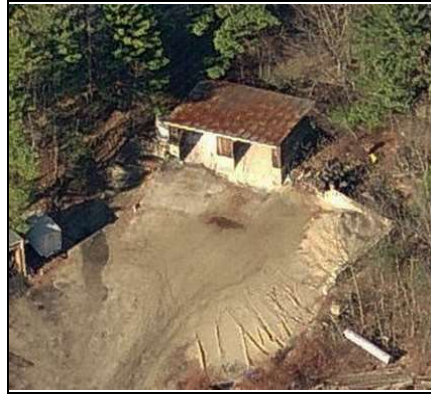
Property: Salt Shed Date of Review: Jan 2014

Roof: Steel Year Installed: _____ Cost: _____ Condition: Poor

Siding: Wood, Board & Batten Year Installed: _____ Cost: _____ Condition: Poor

Comments: Building is part of an ongoing facility evaluation by Weston and Sampson Engineers therefore our conditions assessment has been limited to a brief walk-through. Overall condition of the building is fair and serviceable; siding and roofing may require attention soon. Facility storage size seems to meet the needs of the town, this should be reviewed with the facility director.

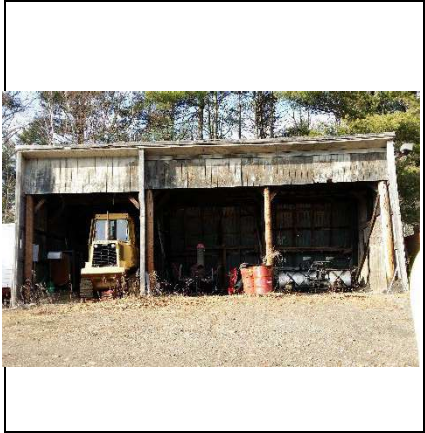
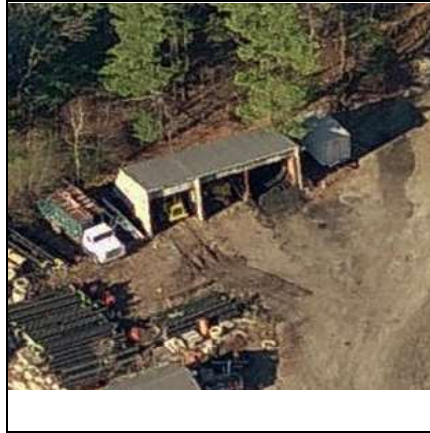
Property: Highway Shed Date of Review: Jan 2014

Roof: Steel Year Installed: _____ Cost: _____ Condition: Poor

Siding: Wood, board & batten Year Installed: _____ Cost: _____ Condition: Poor

General Code Compliance: Use Group U: Building appears to meet the minimal requirements for lifesafety. Structural analysis and upgrades may be required for continued use.

Comments: Building is part ongoing facility evaluation by Weston and Sampson Engineers therefore our conditions assessment has been limited to a brief walk-through. The building appears to have met its useful life, overall condition of the building is poor. The town should anticipate substantial repairs or removal of this structure.

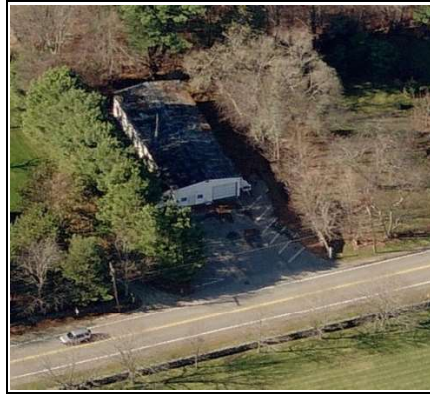
Siding: Vinyl Year Installed: Cost: Condition: Poor

General Code Compliance: Under current Use Group S1 (moderate hazard storage) without human occupancy and with ground level egress/access the building is serviceable.

Comments: Occupancy by staff, Use Group B, would trigger significant upgrades to building systems, thermal envelope (and therefore possibly structure) that would likely rival the residual value of the shell of the building. Reported moisture and mold problems add to poor prospects for re-use without wholesale overhaul.

The **Trolley Barn** has been outgrown, no longer fits the trolley or police function, and would need significant code upgrades to be put back into use for human habitation. While the shell of the building remains basically serviceable, this portion only represents a quarter or less of the value of a useable structure. Continued use as cold storage would represent the path of least resistance, however the presence of an essentially vacant building in the midst of the historic district raises some concern unless better measures to monitor the structure are introduced. Removal should be seriously considered, in our opinion.

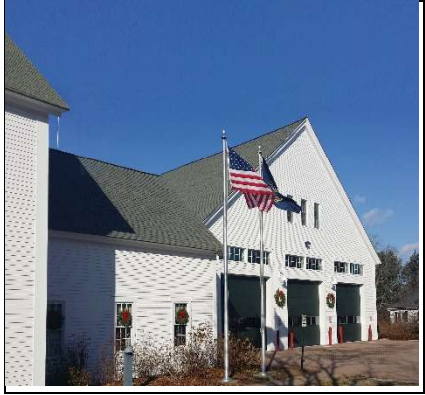
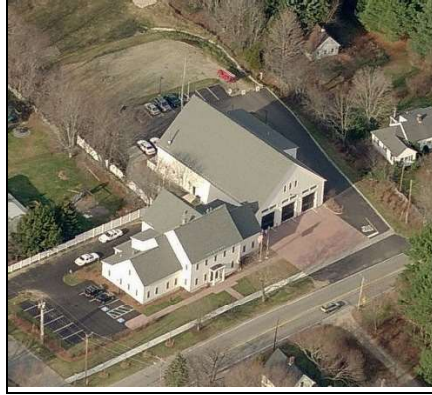
Property: Public Safety Building Date of Review: Jan 2014

General Code Compliance: Use Group B/ S1 (apparatus). The newest facility, this building is also held to a higher standard under the code as an "essential facility," and because it provides sleeping facilities. No apparent code issues noted.

Comments: This building was not conceived of as a public meeting space; retrofitting public assembly space into the building would present challenges under the building code for egress and access, ADA, NFPA regulation and security of police operations. Space over the apparatus bays would require rated separation due to mixed uses

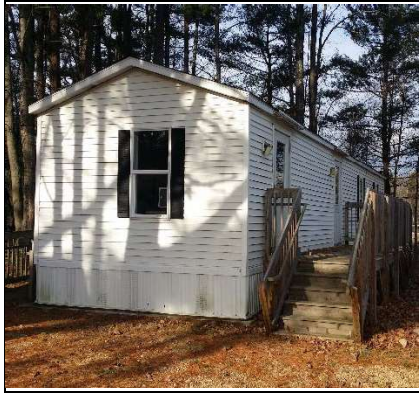
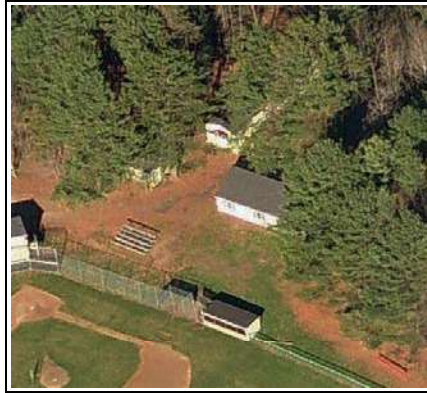
Property: Recreation Modular 1 Date of Review: Jan 2014

General Code Compliance: Use Group A-3: Building appears to meet the minimal requirements for lifesafety. We believe the building will not meet current energy codes or the guidelines for accessibility.

Comments: Overall the facility is in serviceable condition, exterior wood decks will require ongoing maintenance and repairs. Building is well used though recreation activities seem to be severely limited given the size of the building.

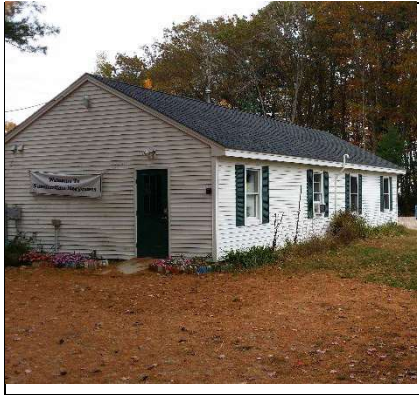
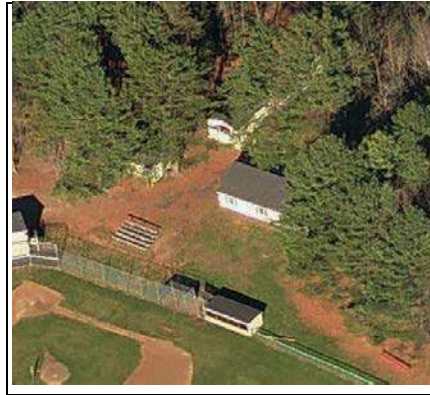
Property: Recreation 2 Date of Review: Jan 2014

General Code Compliance: Use Group A-3: Building appears to meet the minimal requirements for lifesafety. We believe the building will not meet current energy code.

Comments: Overall the facility is in serviceable condition, though the interior finishes seem to be near the end of their useful life. The exterior wood deck/ramp at the bathrooms will require ongoing maintenance and repairs. Building is well used though recreation activities seem to be limited given the size of the program area.

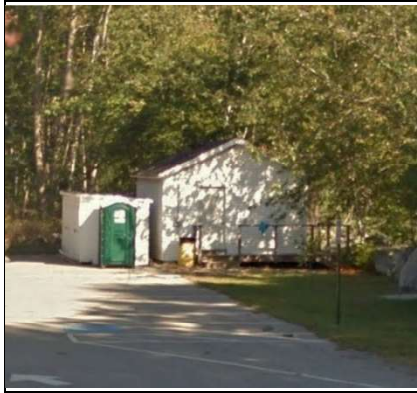
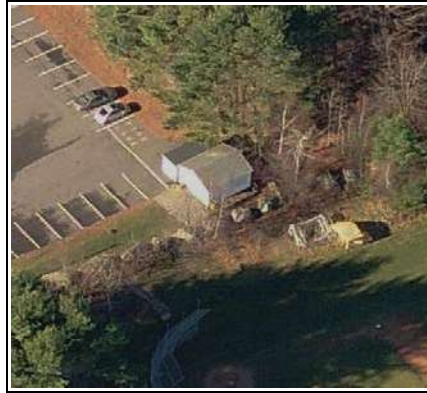
Property: Snack Shack Date of Review: Jan 2014
Address: Recreation Road Tax Map/Lot: 12/81
Year Built: _____ Initial Cost: _____ Maintained by: Recreation

General Code Compliance: Use Group S-1; Building does not meet accessibility guidelines

Comments: Building is primarily a storage building, snack serving area if very limited, both in size and use. Cold storage only, space not appropriate for food storage. Overall size for a snack shack seems appropriate; use as storage for recreation materials does not seem functionally efficient.
