April 23, 2018

Chief Mark Cotreau
Rye Fire Department
555 Washington Road
Rye, NH 03870

At your request I have evaluated the fire apparatus fleet being presently used by the Rye Fire Department. The purpose of this evaluation was to give you a quick overview of issues with the trucks. For a more in depth review we would need to bring them to our service center for a full evaluation of the pumps, motors, transmissions, and springs.

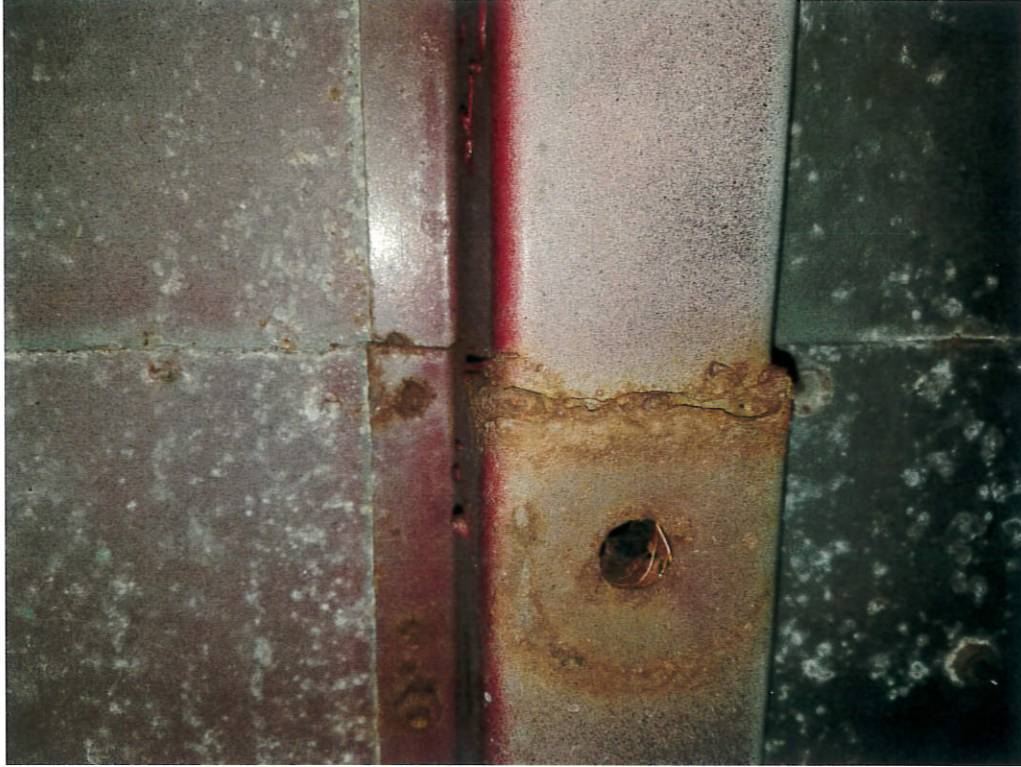
Engine 1 is 25 years old, and built on a medium duty commercial chassis. Serious rust is present on the chassis frame, pump, and under the cab.

Rust under the cab, which is made of metal;

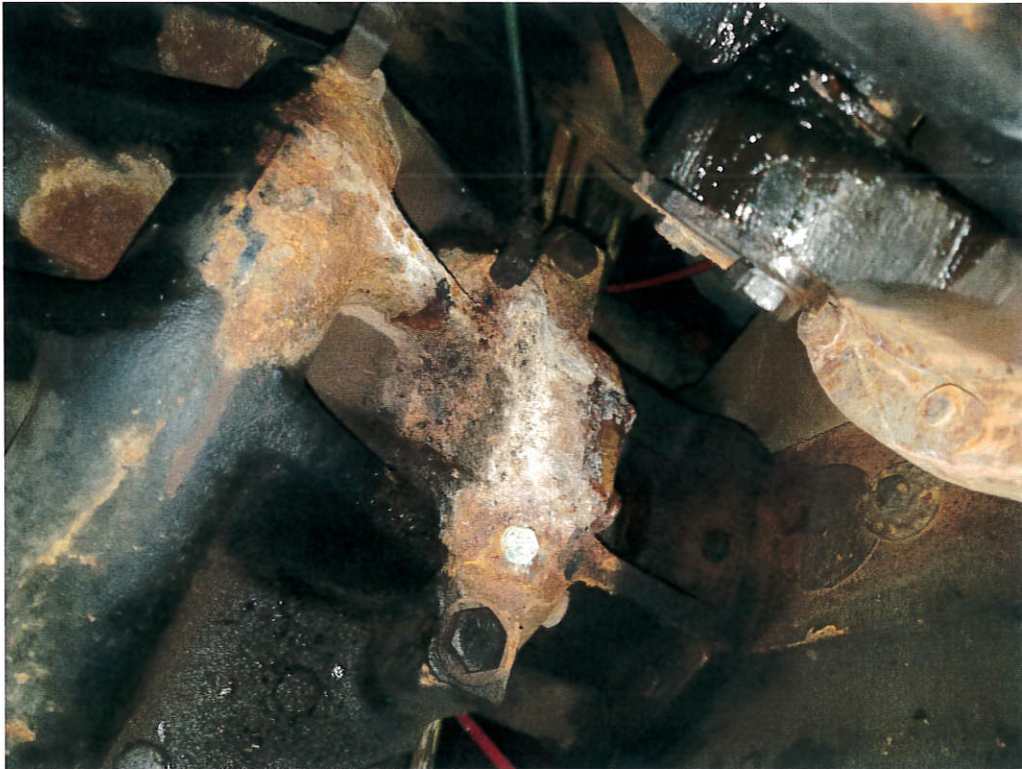
The pump passes a function test, based on the numbers provided it exactly matches the original test plate from 1993, which is virtually impossible. Based on what the condition of the pump looks like and the age of the truck I would say it needs a rebuild in the near future.

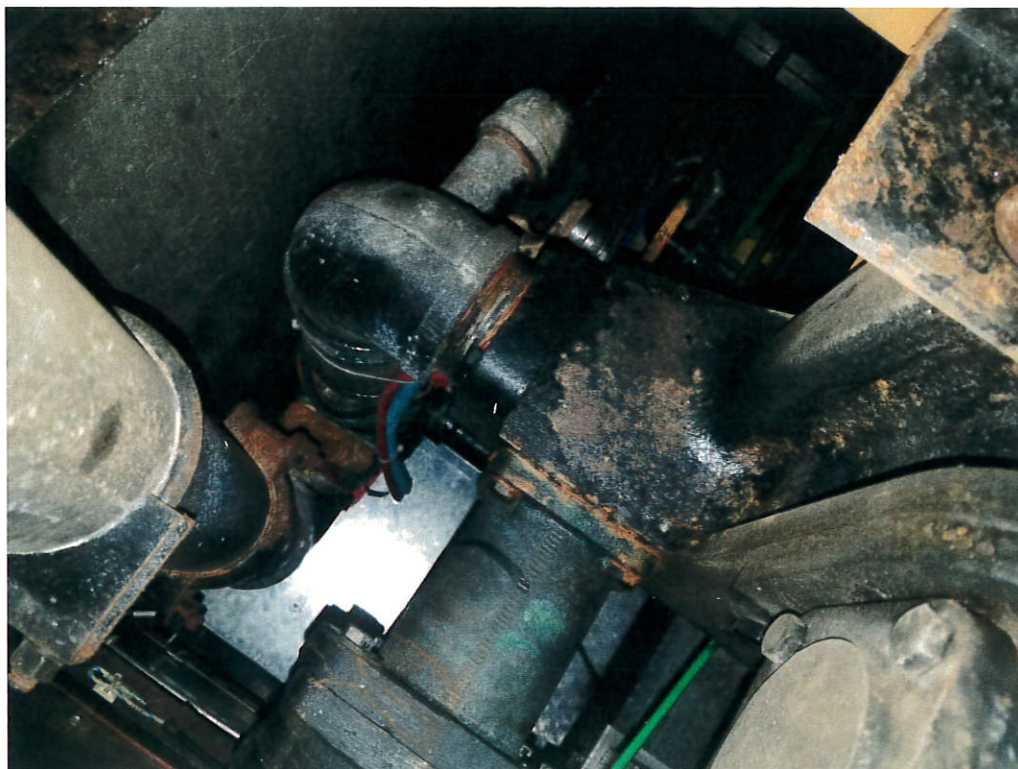
Plumbing; The plumbing is original and made from untreated steel. The plumbing shows signs of significant rust and is in need of repair/replacement at the same time the pump is repaired.

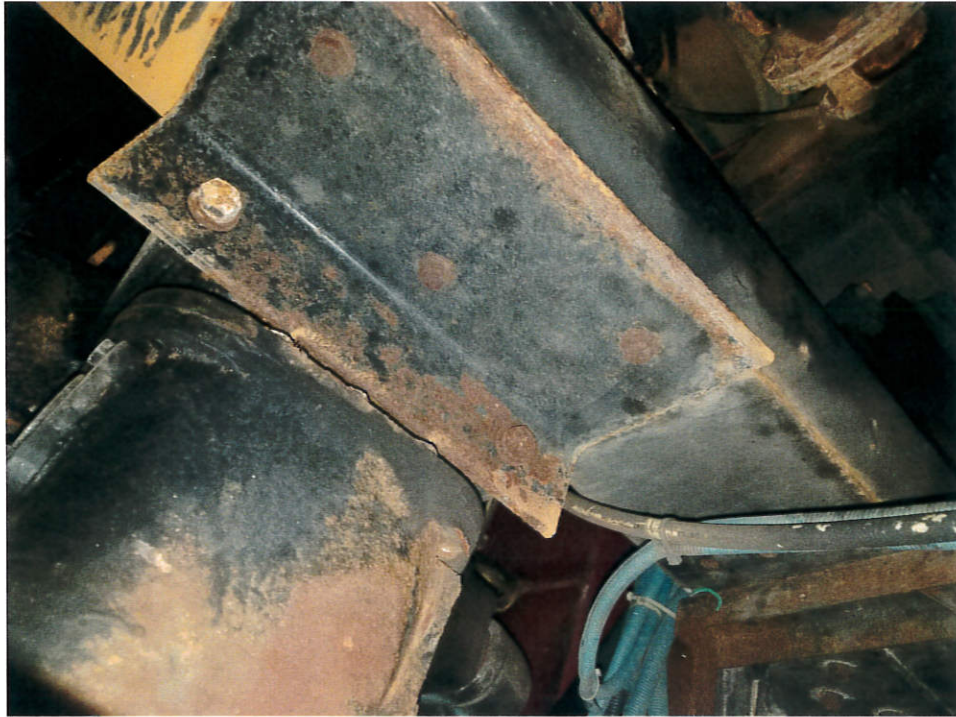
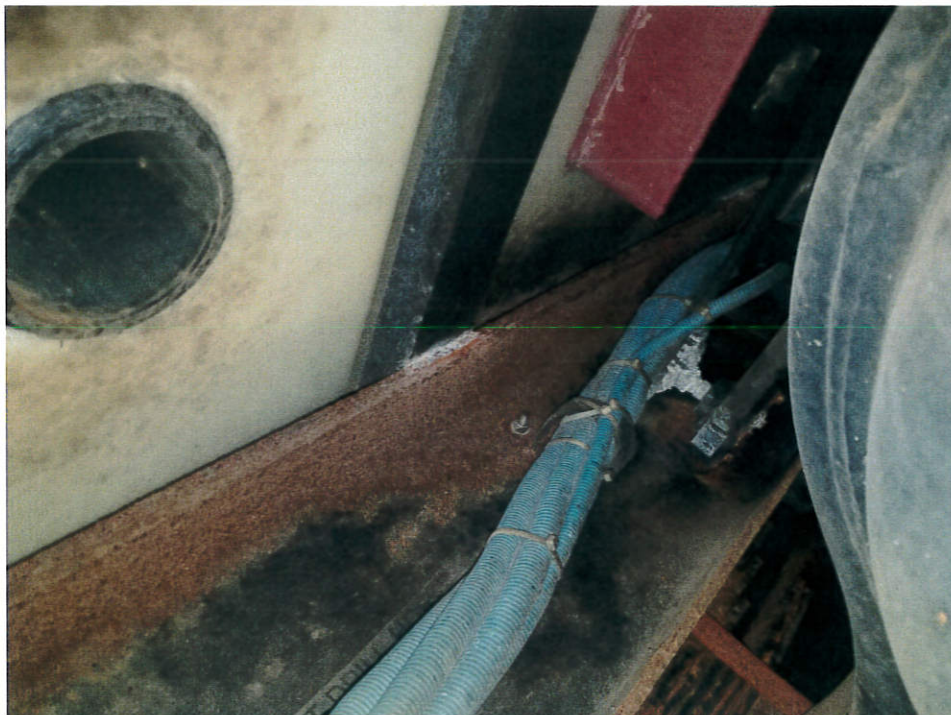
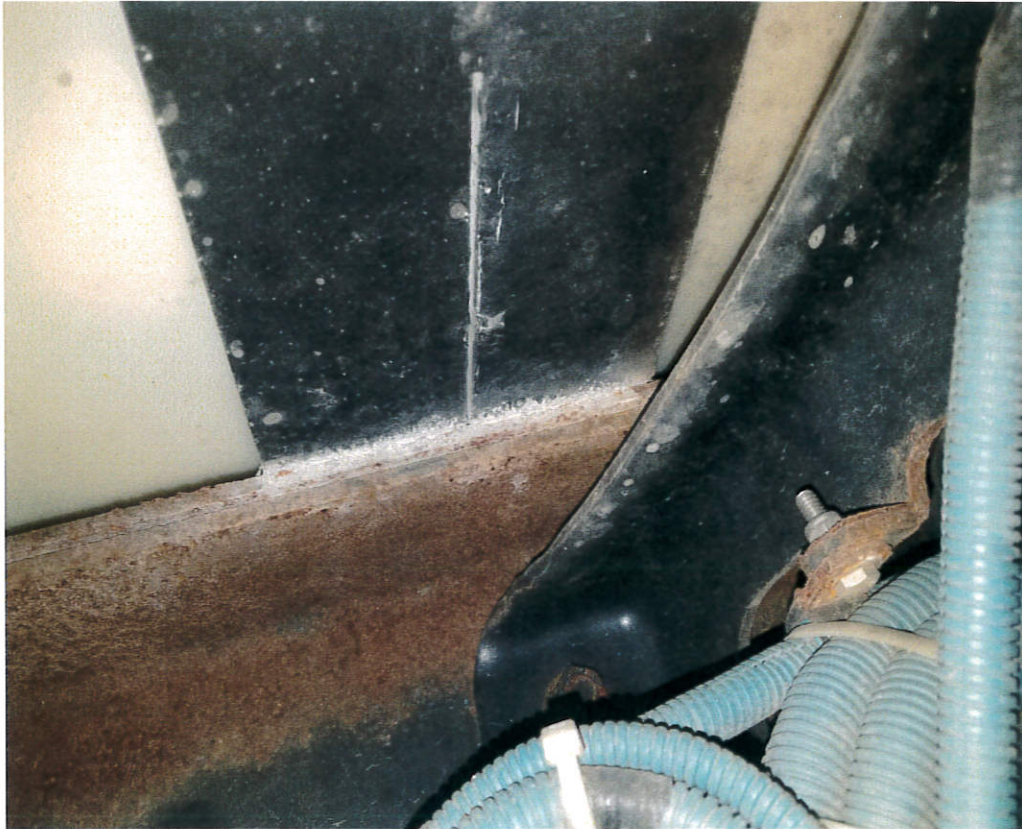
Frame- This is an area of serious concern, this truck has seen duty for 25 winters in New Hampshire and been exposed to road treatment chemicals. The frame shows signs of rust and based on my experience if left unrepaired the frame will be damaged beyond repair in just a few more years. The white powder on the frame in these photos is road treatment that has worked it's way between the truck frame and body frame, both of which are untreated metal.

My conclusion for Engine 1 is that it's a 4/10 for condition and a 5/10 for serviceability. The truck lacks many features common to modern apparatus and is in need of expensive repairs to the pump, plumbing, and frame. It is my estimation that that truck would require approximately \$75,000 in repairs to extend the service life another 5-10 years, and this does not include upgrades. At 25 years old this truck is at the end of service life by most standards.

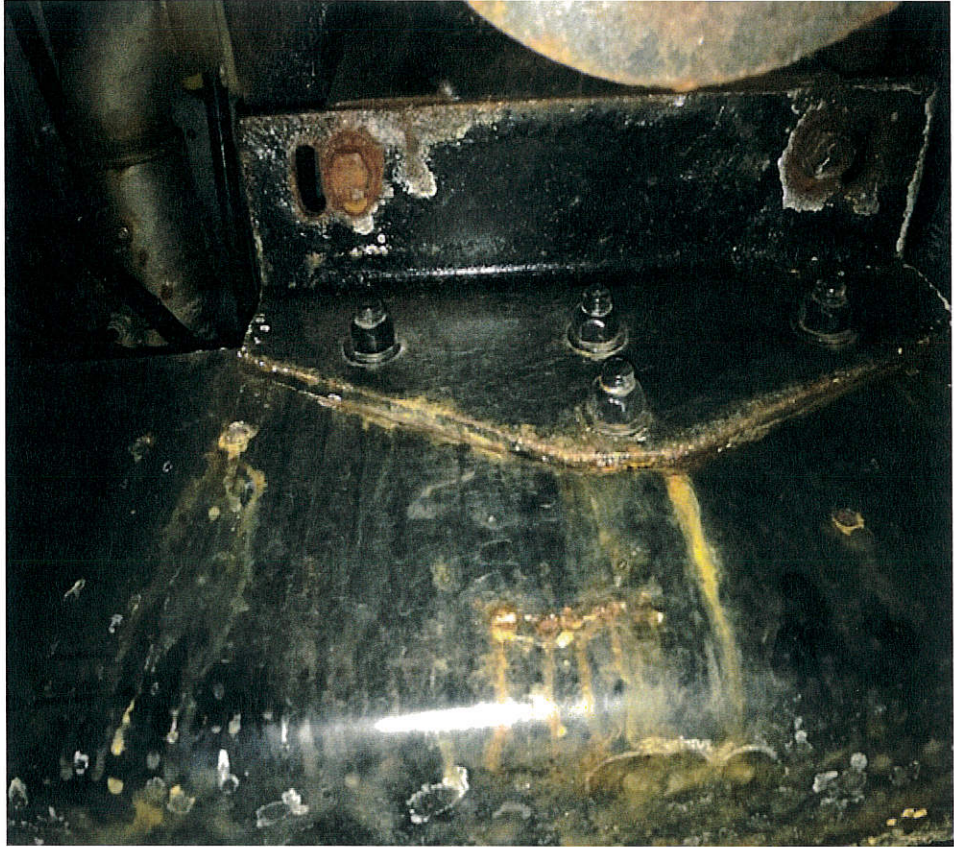
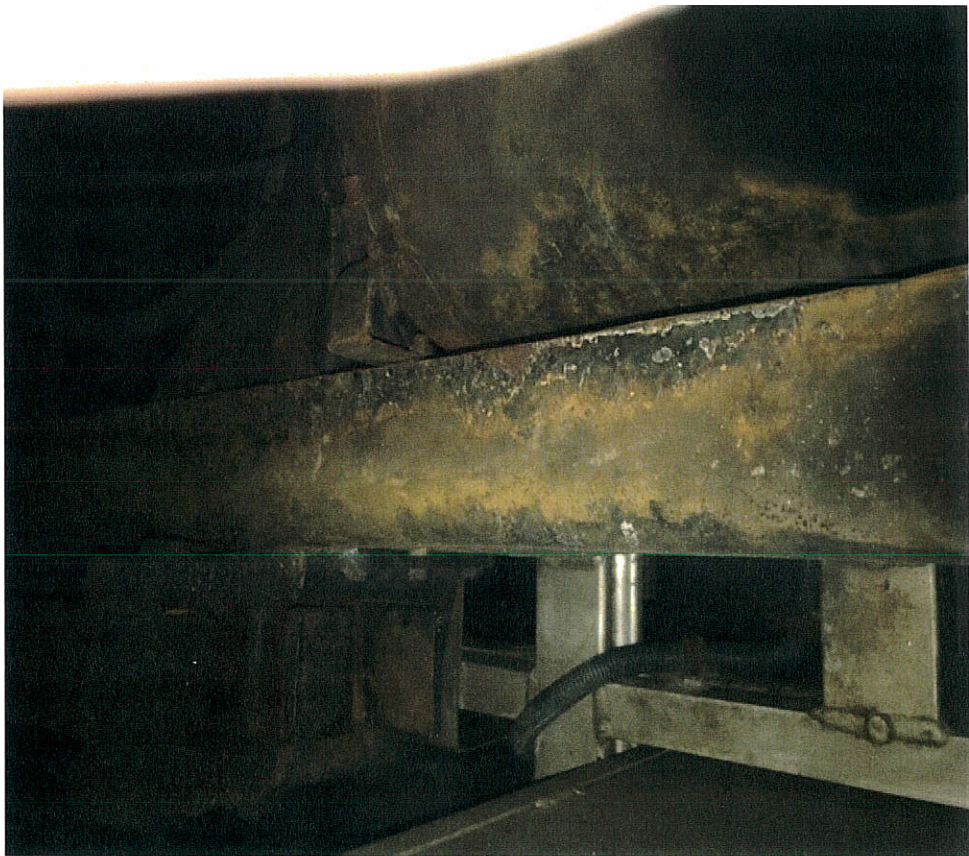
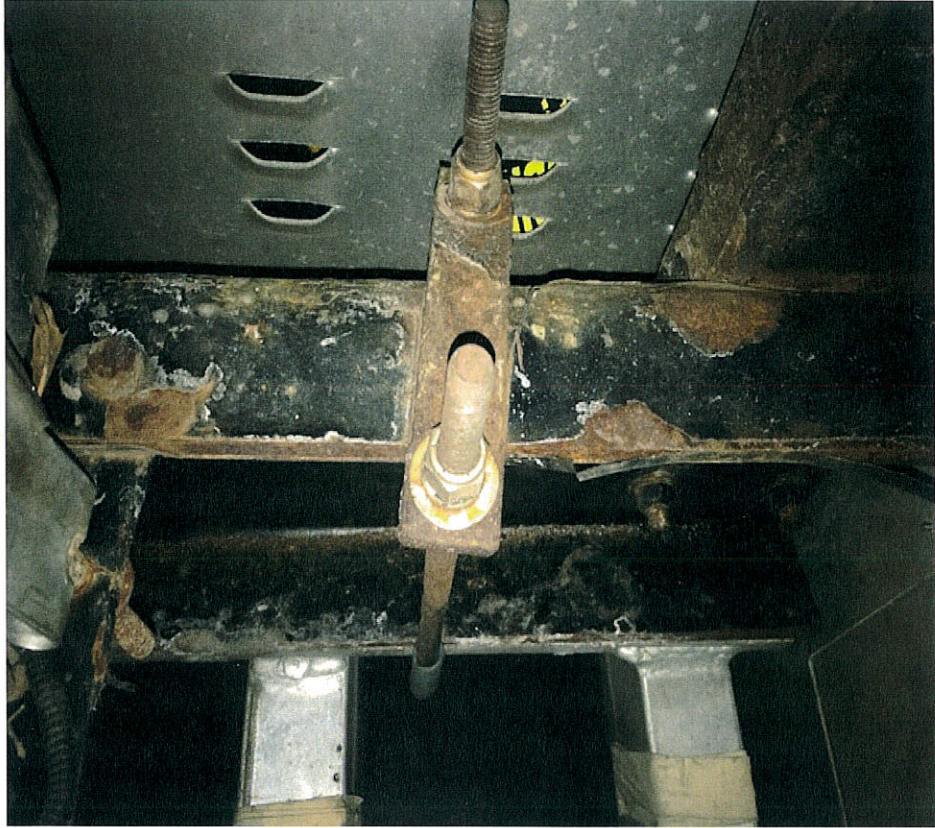
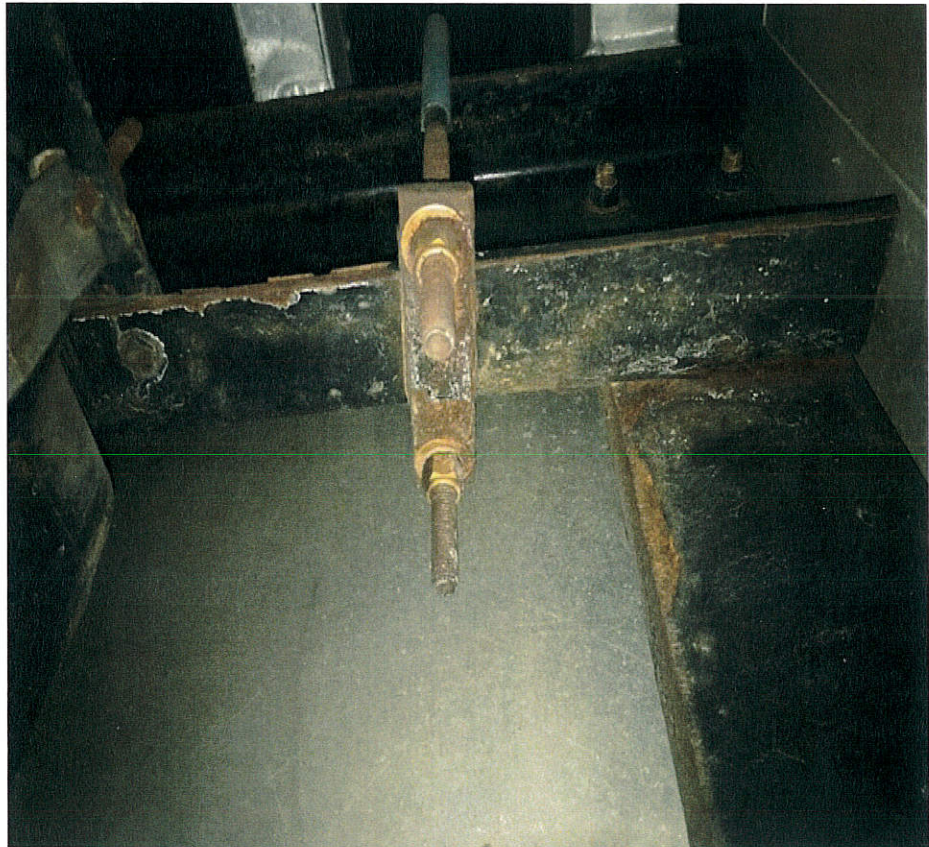
Body- The body shows signs of surface corrosion from contact with road chemicals and reaction by the aluminum body. To preserve the apparatus I would suggest a repaint.

Frame- The frame is showing signs of surface rust and should be addressed ASAP to prevent this issue from becoming beyond repair. A frame sandblast and repaint is advised.

I would estimate that Engine 3 requires a mid-life refurbishment in the range of \$100,000-\$150,000 to assure it makes it's desired service life. Overall condition is 6/10 and Serviceability is 7/10. This would still be considered a "modern" piece of apparatus.

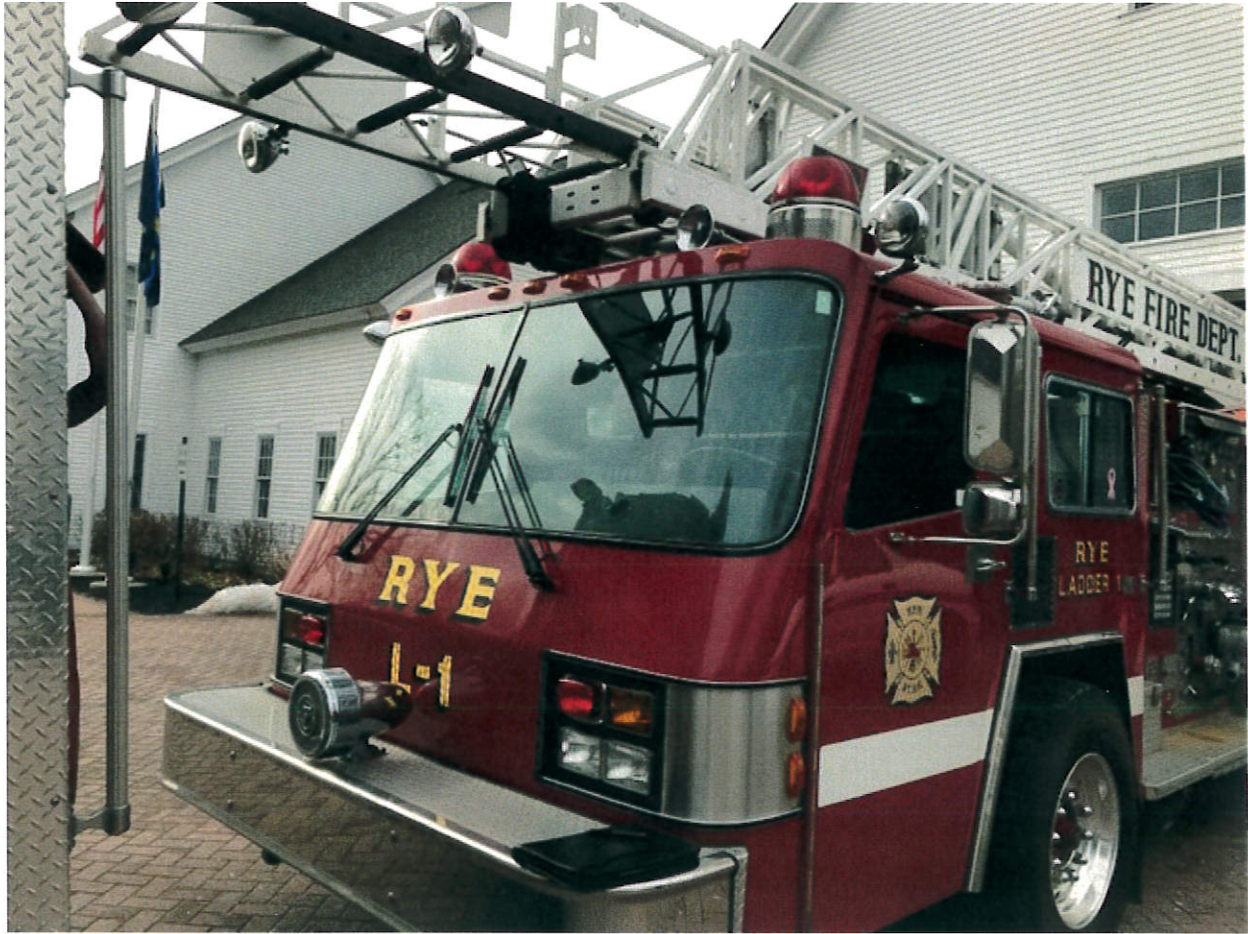
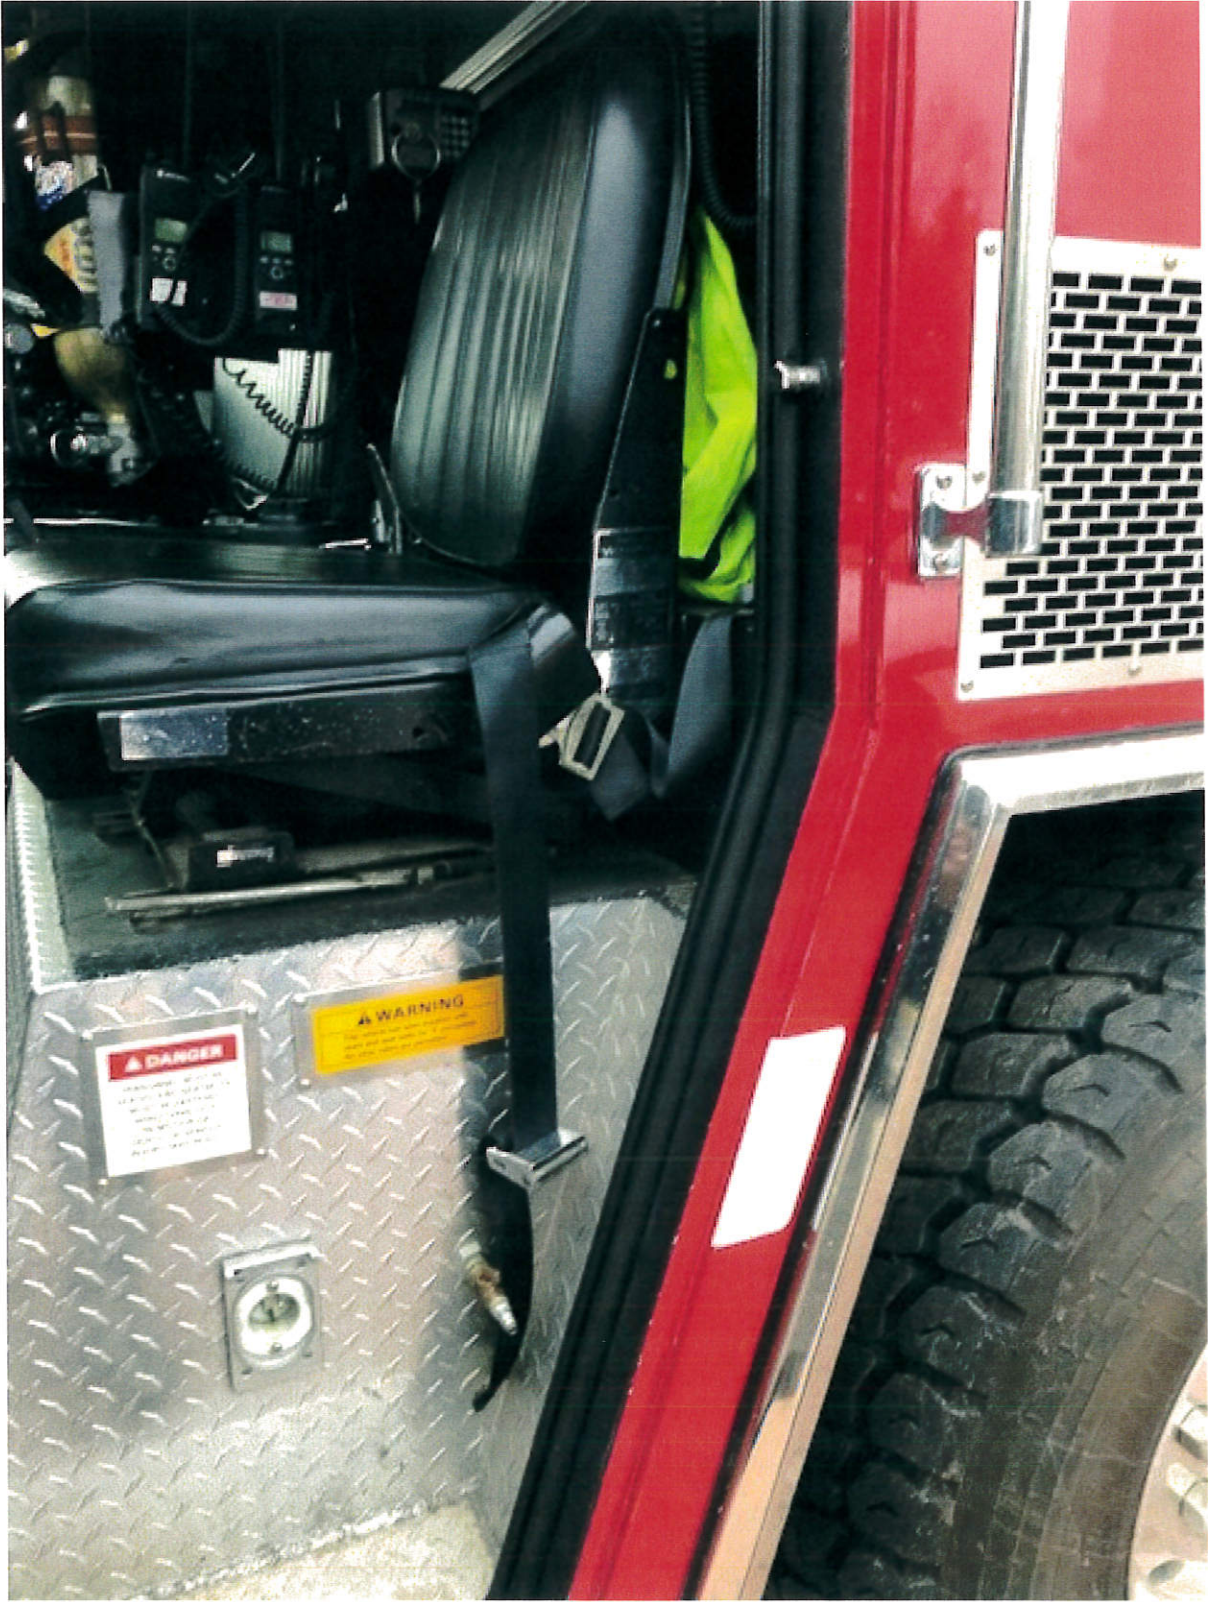
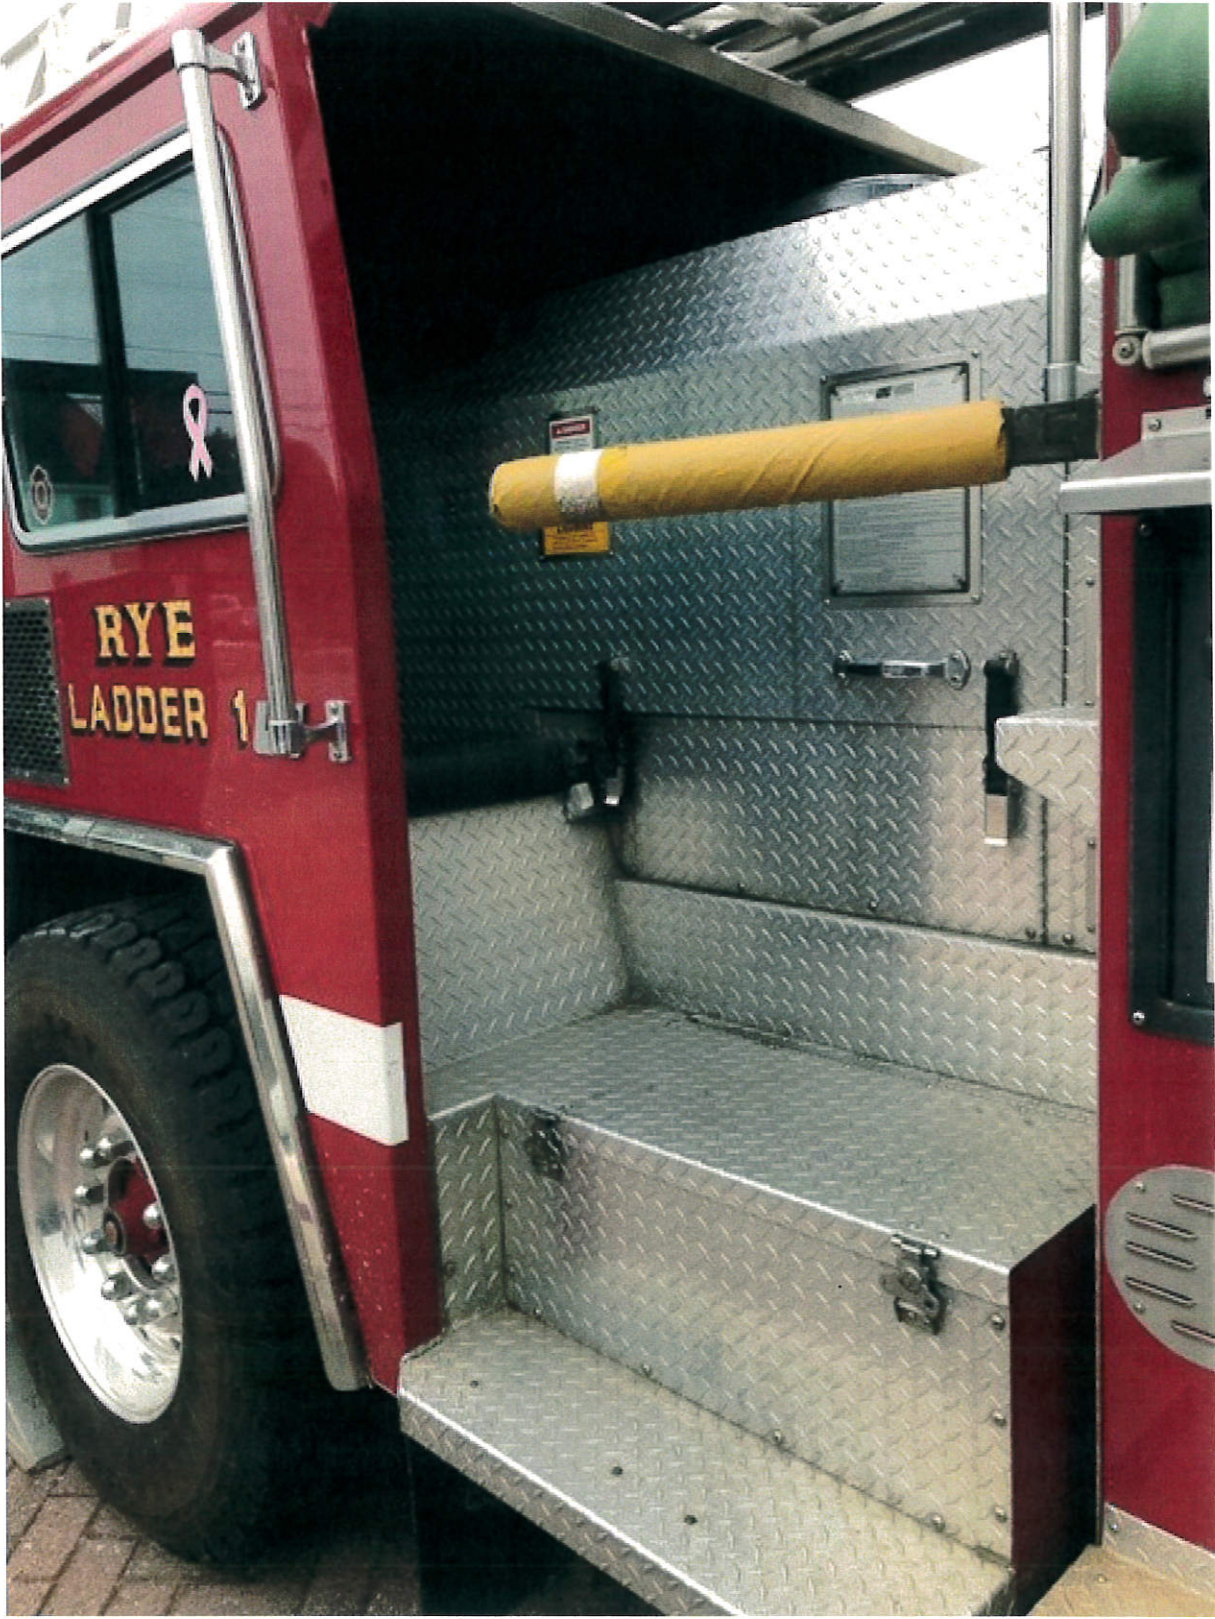
There are many issues that are readily apparent when evaluation the apparatus. Most of these issues are related to firefighter safety. This apparatus has outside seating (canopy cab) that places firefighters in harms way with only a small padded metal bar to hold them into the cab, this has been deemed unsatisfactory for 27 years. The cab has lap belts only, which is likewise very unsatisfactory. The vehicle has sirens/airhorns on the cab roof which has been proven to cause hearing damage/loss to firefighters. The vehicle also lacks ABS brakes, which is a very basic safety feature.

In conclusion I would consider Ladder 1 a 3/10 for condition and a 1/10 for serviceability. I would not spend any additional money on this apparatus and would strongly advise to replace it as soon as possible. Given the large body of information published about the dangers of older apparatus like Ladder 1 there is little ability to operate this truck in good conscious.
