GENERAL PHYSICAL CONDITION ASSESSMENT REPORT

Rye Second Parish Apartments
575 Washington Rd
Rye, NH 03870

Inspection Date: June 3, 2015

Rye Second Parsonage Apartment Facility Evaluation

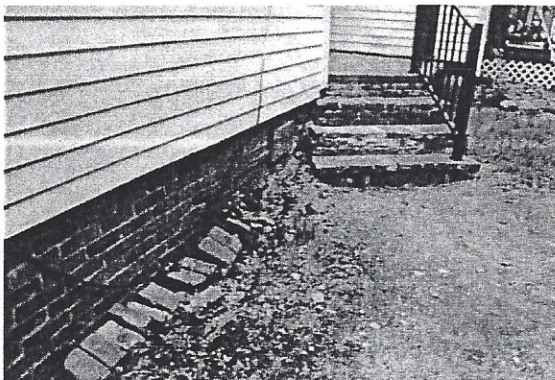
Figure 3 Apartment path and masonry stair repair

Exterior staircases to the second floor are pressure treated wood and the stringers and the posts have been repaired recently. Stairs are not level and are built with open risers. First floor apartments are served by brick stairs. One unit has a temporary repair to the brick that needs to be repaired to be level and have correct nosing. No unit is currently wheelchair accessible.

- Bulkhead doors need to be replaced to prevent water from entering basement.
- Carriage house water heater needs to be evaluated because of water in the drain pan.
- Masonry stairs need to be repaired to meet current stair code. Current temporary repair does not provide any nosing.

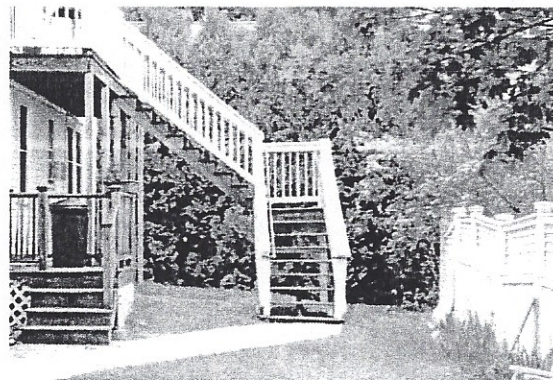
Figure 4 Second floor apartment stairs and rear fence

Pathways are made of several different materials including concrete, concrete pavers and brick pavers. They appear to be in acceptable condition for wear. One apartment does not have a paved path to the entrance and is only accessible by walking across the grass yard. Yard fence adjacent to the library parking lot has support issues where the posts enter the ground and is assumed to have rotted below grade.

- Heating system boiler is at the end of its lifespan and should be replaced with a new more efficient boiler.
- Second floor apartment stairs and railings are reaching the end of their usable life and should be replaced. Existing stairs show signs of rot and are not level walking surfaces. Repairs have been made to sustain the structural integrity of the stair stringers but overall condition warrants replacement.
