Project No.: 20279-01

Date: July 22, 2023

Location: Marsden Woods Subdivision, Long John Road – Rye, NH

FIELD REPORT

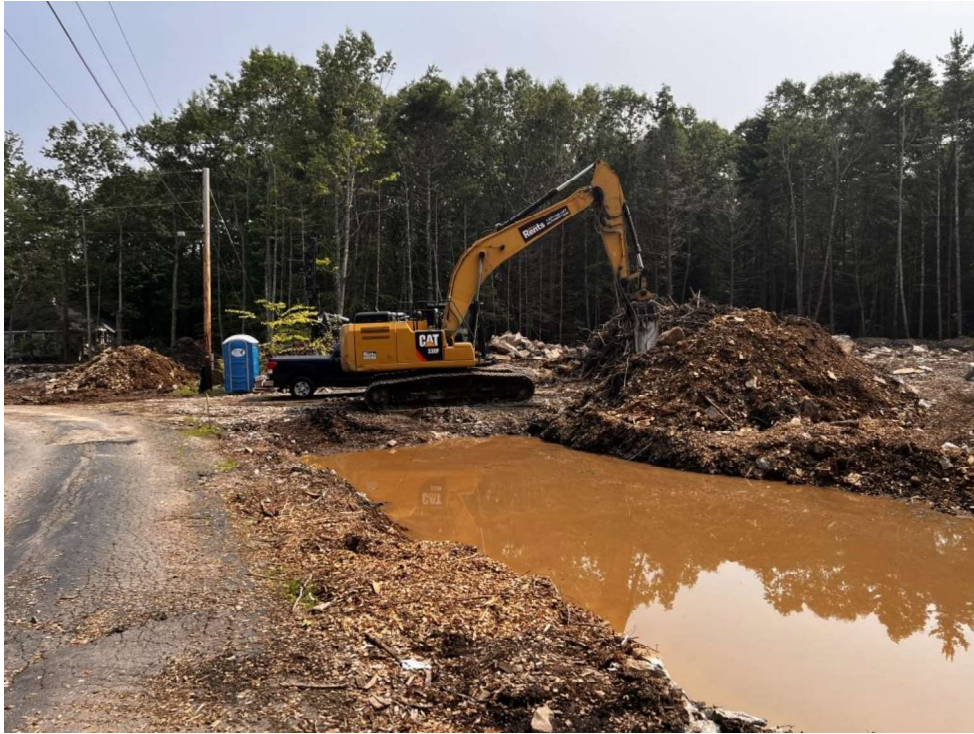
Photo 1 (07-17-23): Excavated area of drainage swale toward area of proposed driveway for single family unit.

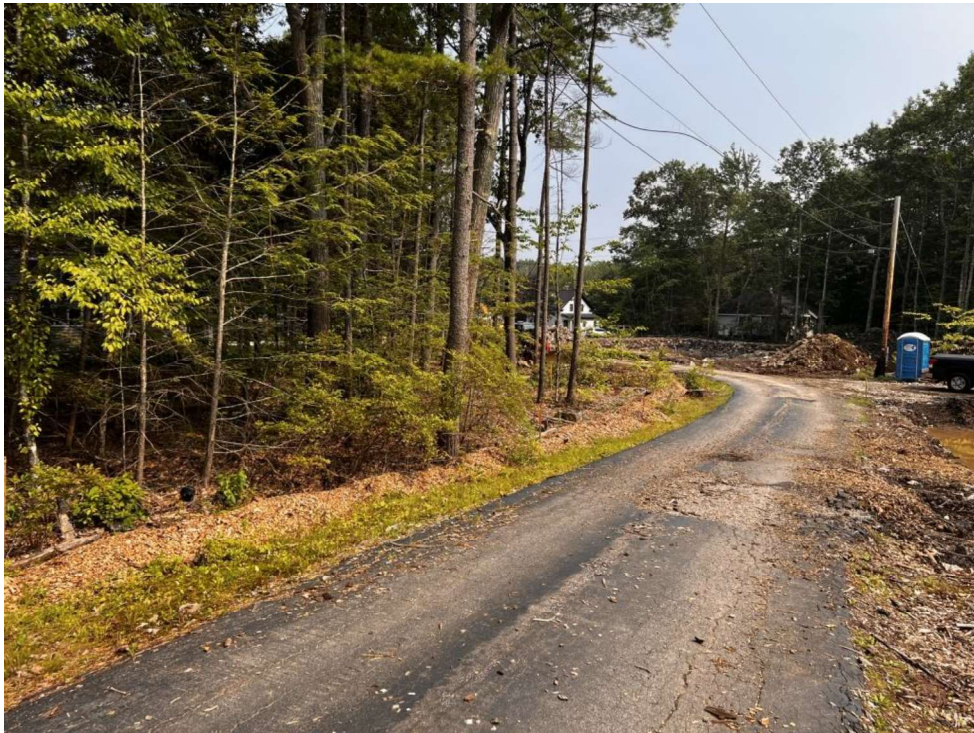
Photo 2 (07-17-23): Existing driveway to 711 Long John Road facing south.

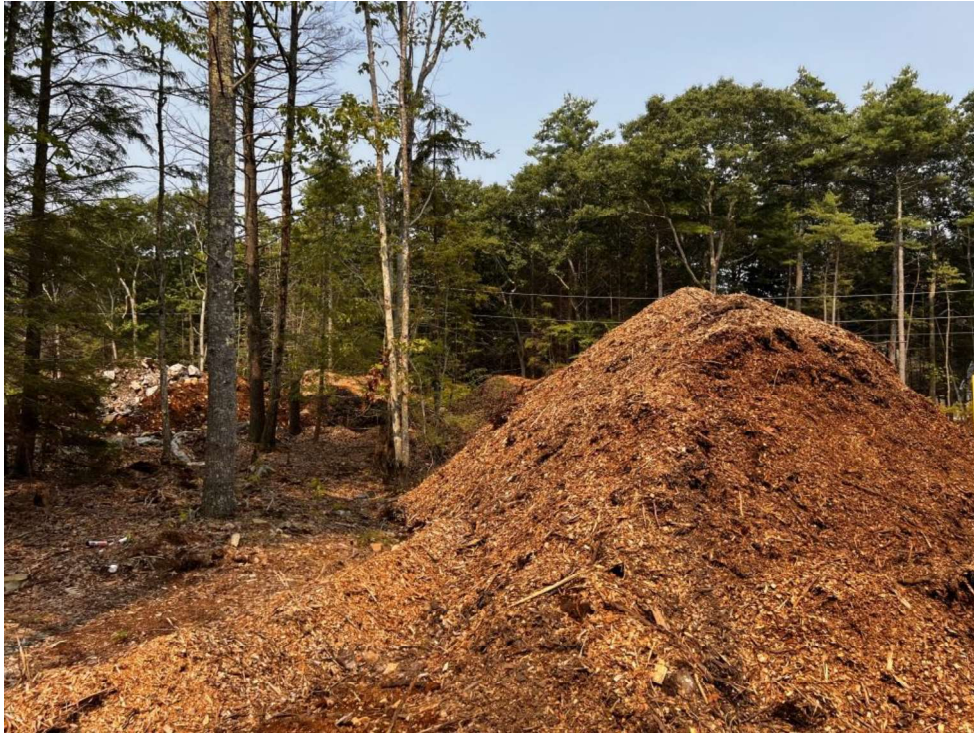
- As discussed at the pre-construction meeting and noted in our previous field reports, the light weight of wood chips makes their use in an erosion control mix berm problematic. The contractor has placed these type of ECM berms along the sides in areas not receiving runoff or in locations of significant fill. The contractor will need to closely monitor the wood chip berms and be prepared to replaced them should detrimental conditions arise.
- Minor tracking of material onto Long John Road was observed where the water main was installed. Contractor shall monitor area and touch up when necessary.

Photo 3 (07-17-23): Wood chip pile being utilized for erosion control mix berms along perimeter of site.

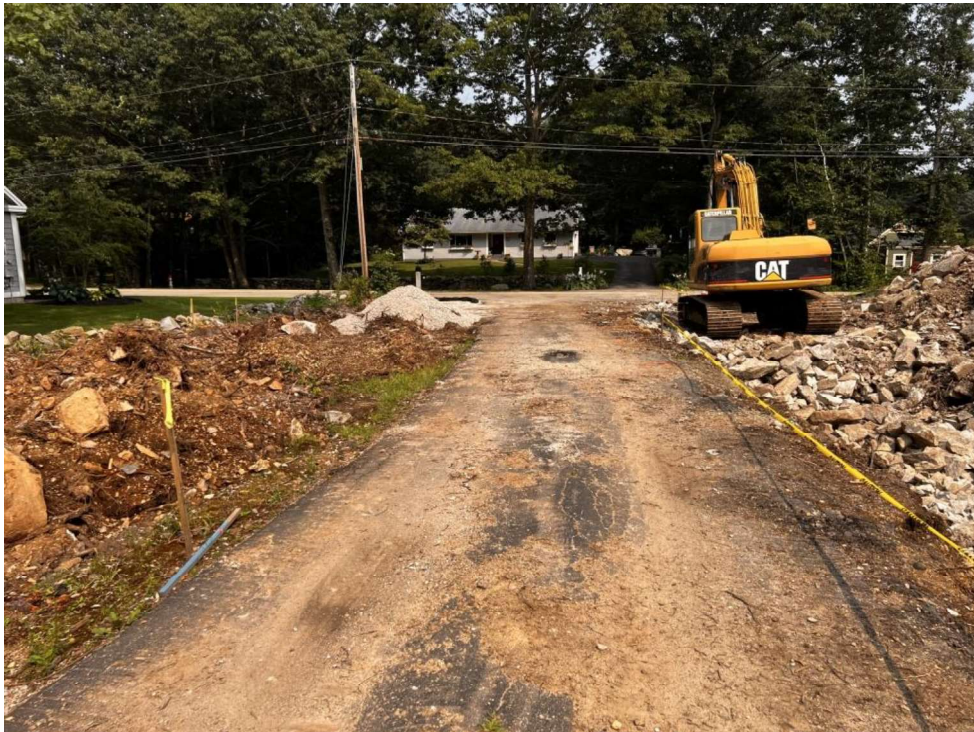
Photo 4 (07-17-23): Existing driveway facing Long John Road.

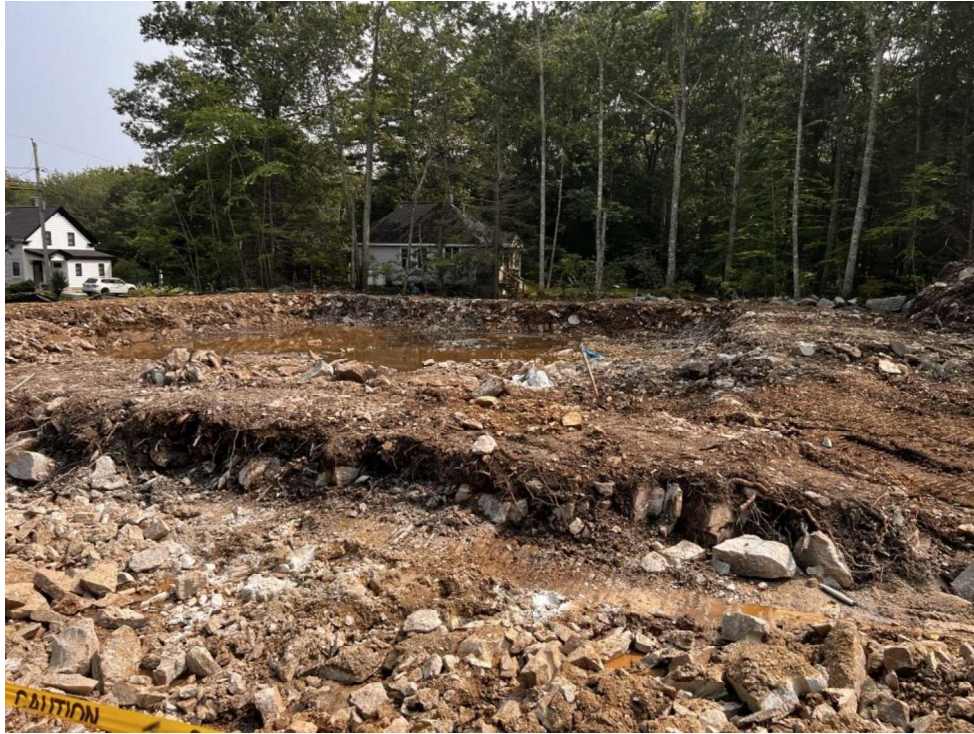
Photo 5 (07-17-23): Overall area of Bio-Retention Area #1 with blasted ledge removed.

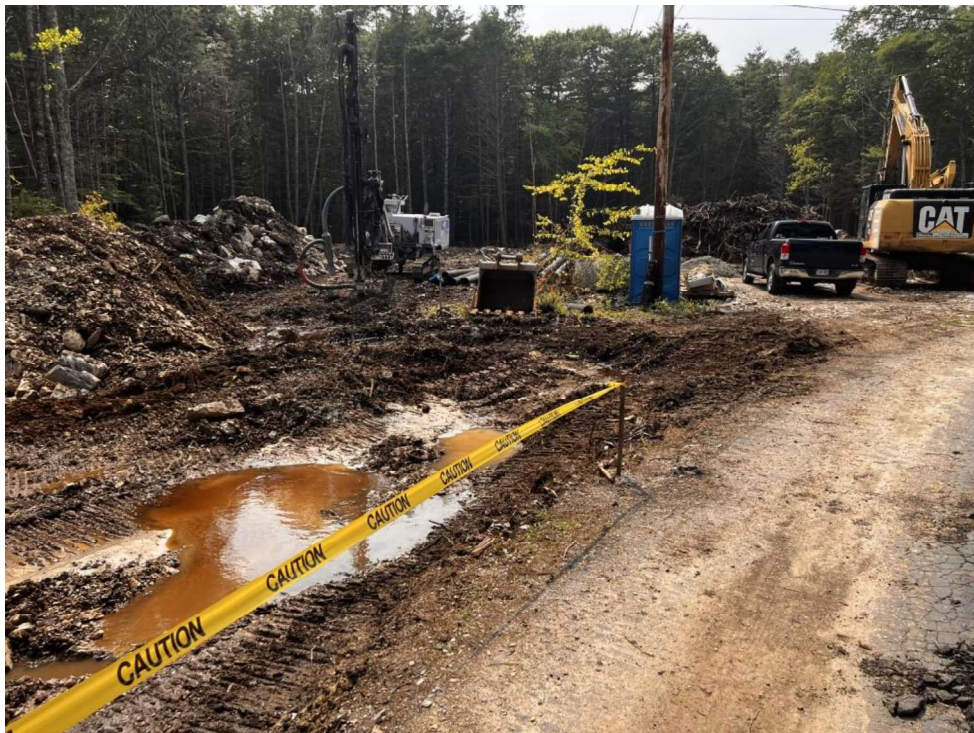
Photo 6 (07-17-23): Excavated area of sediment forebay for Bio-Retention Area #1.

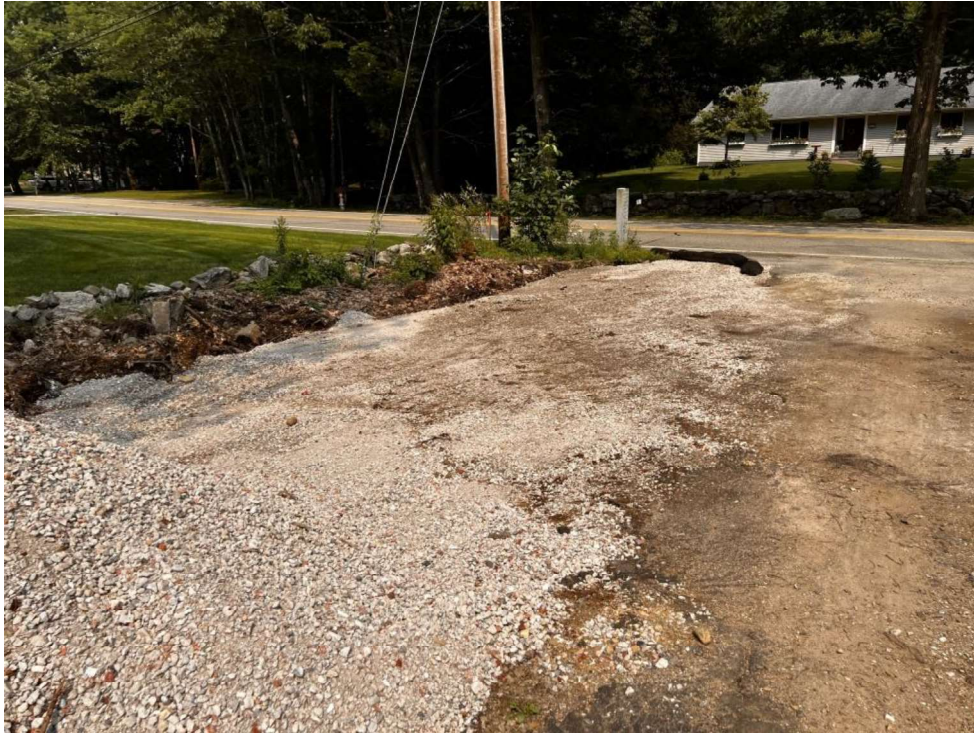
Photo 7 (07-17-23): North side of main entrance to site with erosion control silt sock placed at Long John Road.

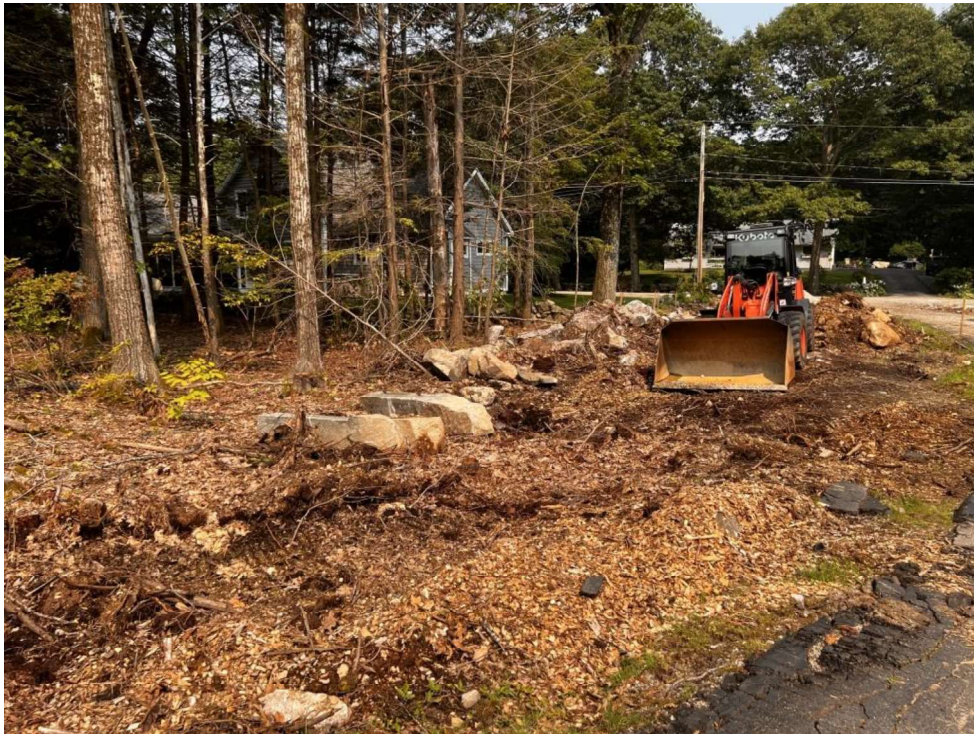
Photo 8 (07-17-23): Site clearing along north side of existing driveway facing Long John Road.

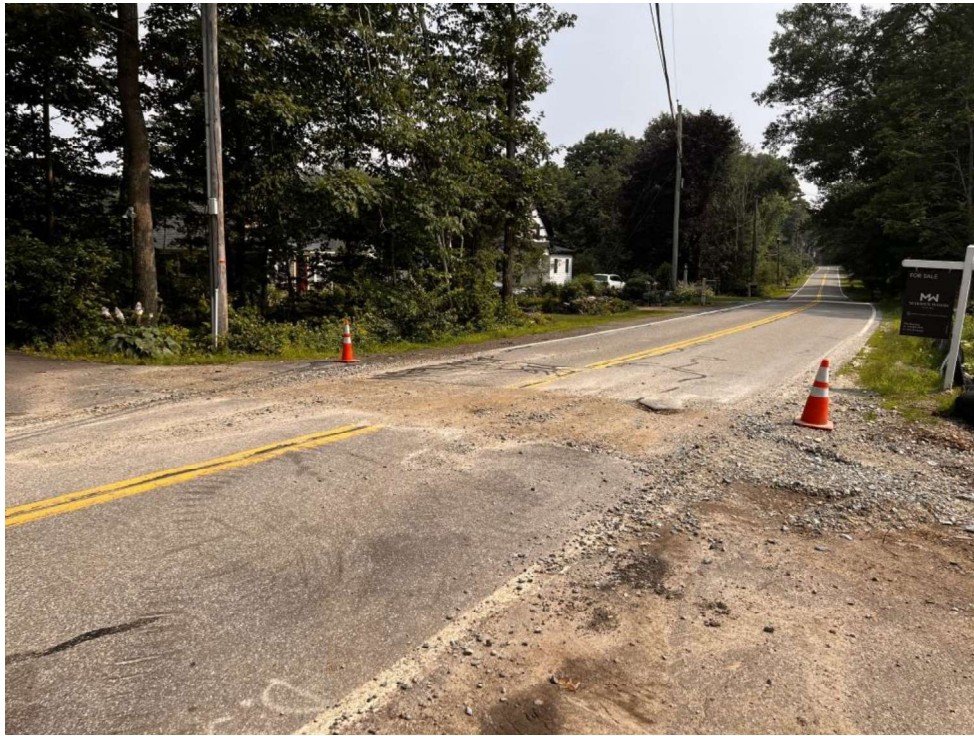
Photo 9 (07-17-23): Site entrance at Long John Road with trench cut for water main installation.

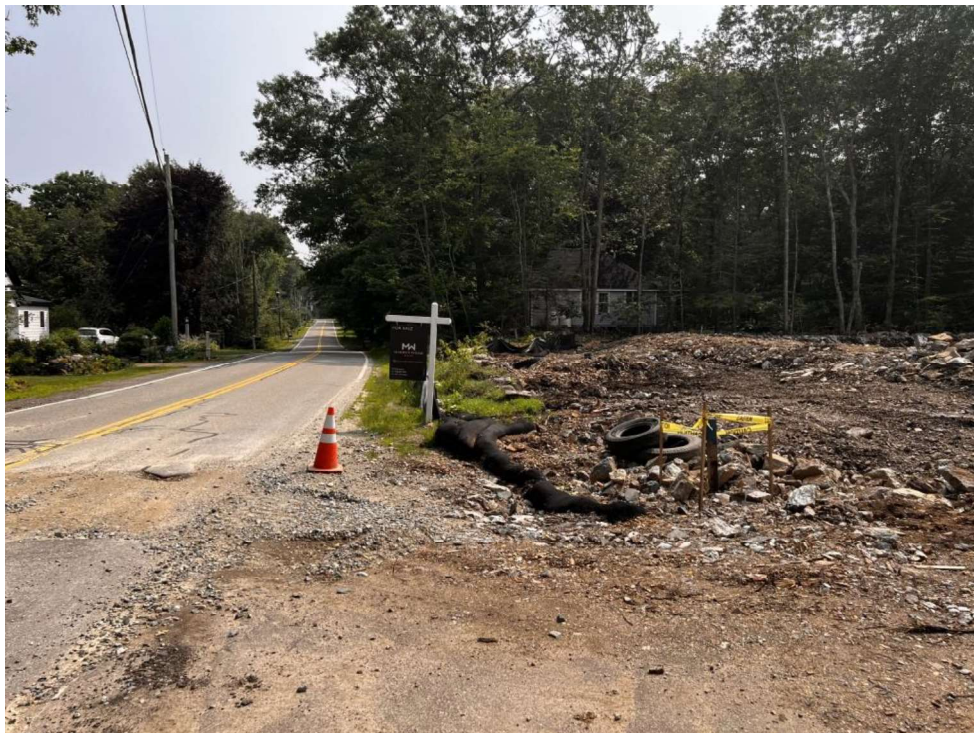
Photo 10 (07-17-23): Erosion control silt fence and silt sock installed on site along Long John Road.

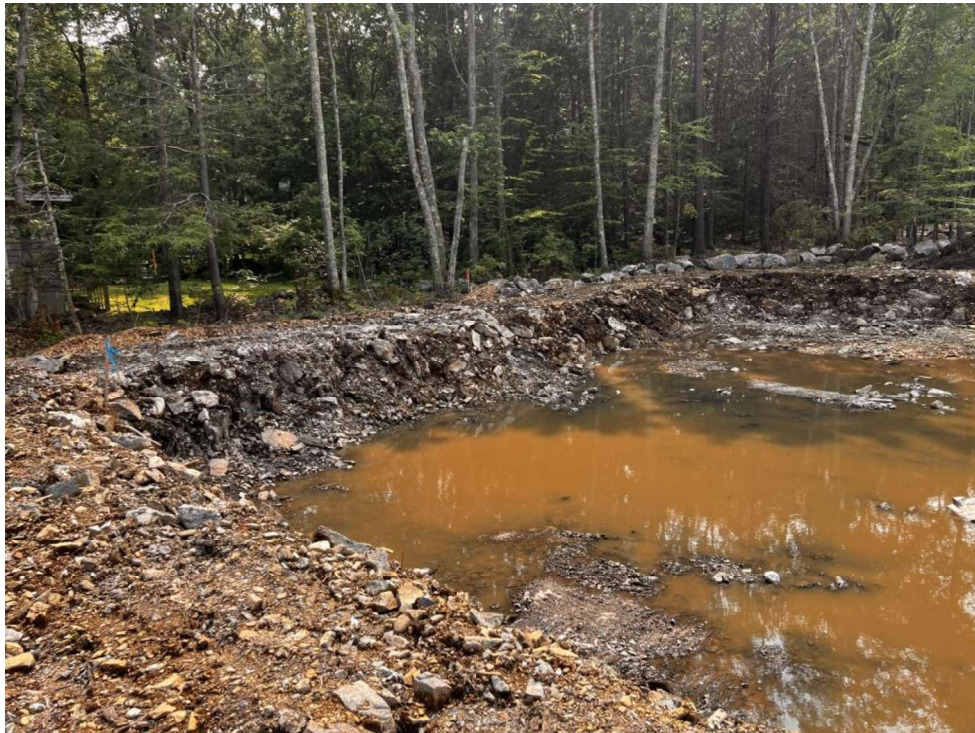
Photo 12 (07-17-23): Excavated area for Bio-Retention #1.

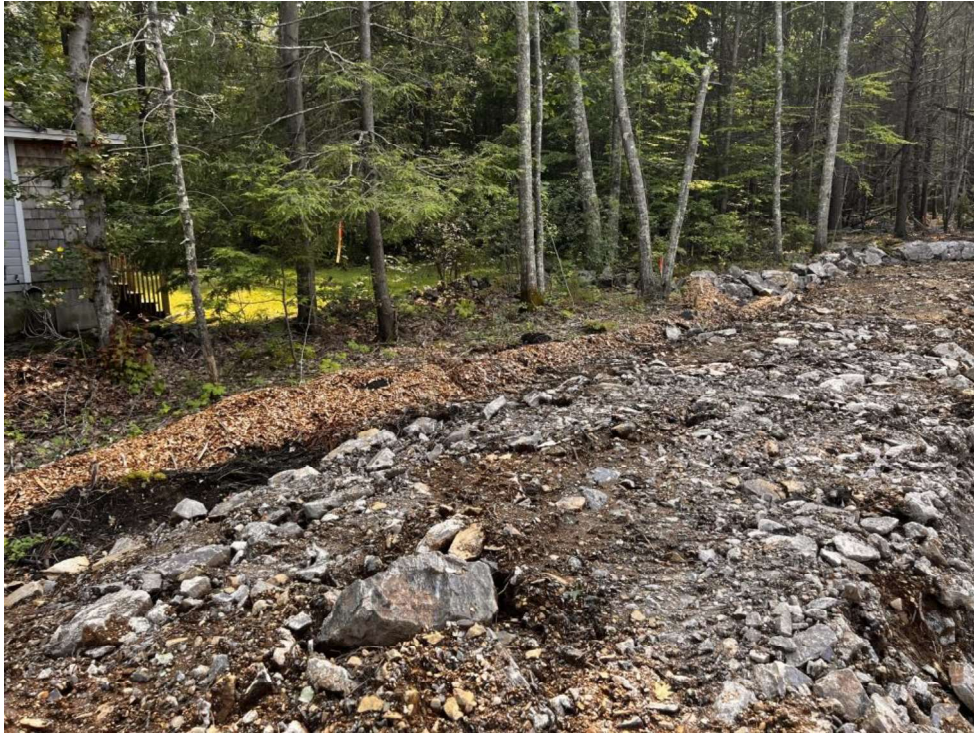
Photo 13 (07-17-23): Erosion control mix berm placed around perimeter of site and in good condition.

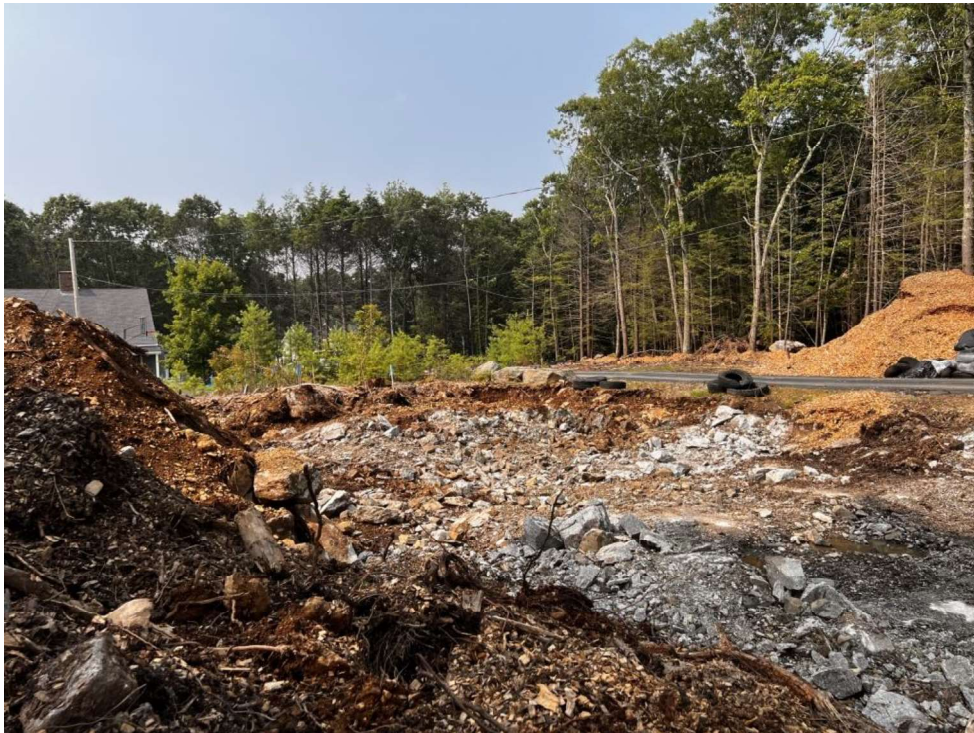
Photo 14 (07-17-23): Removal of ledge along existing driveway toward 711 Long John Road dwelling.

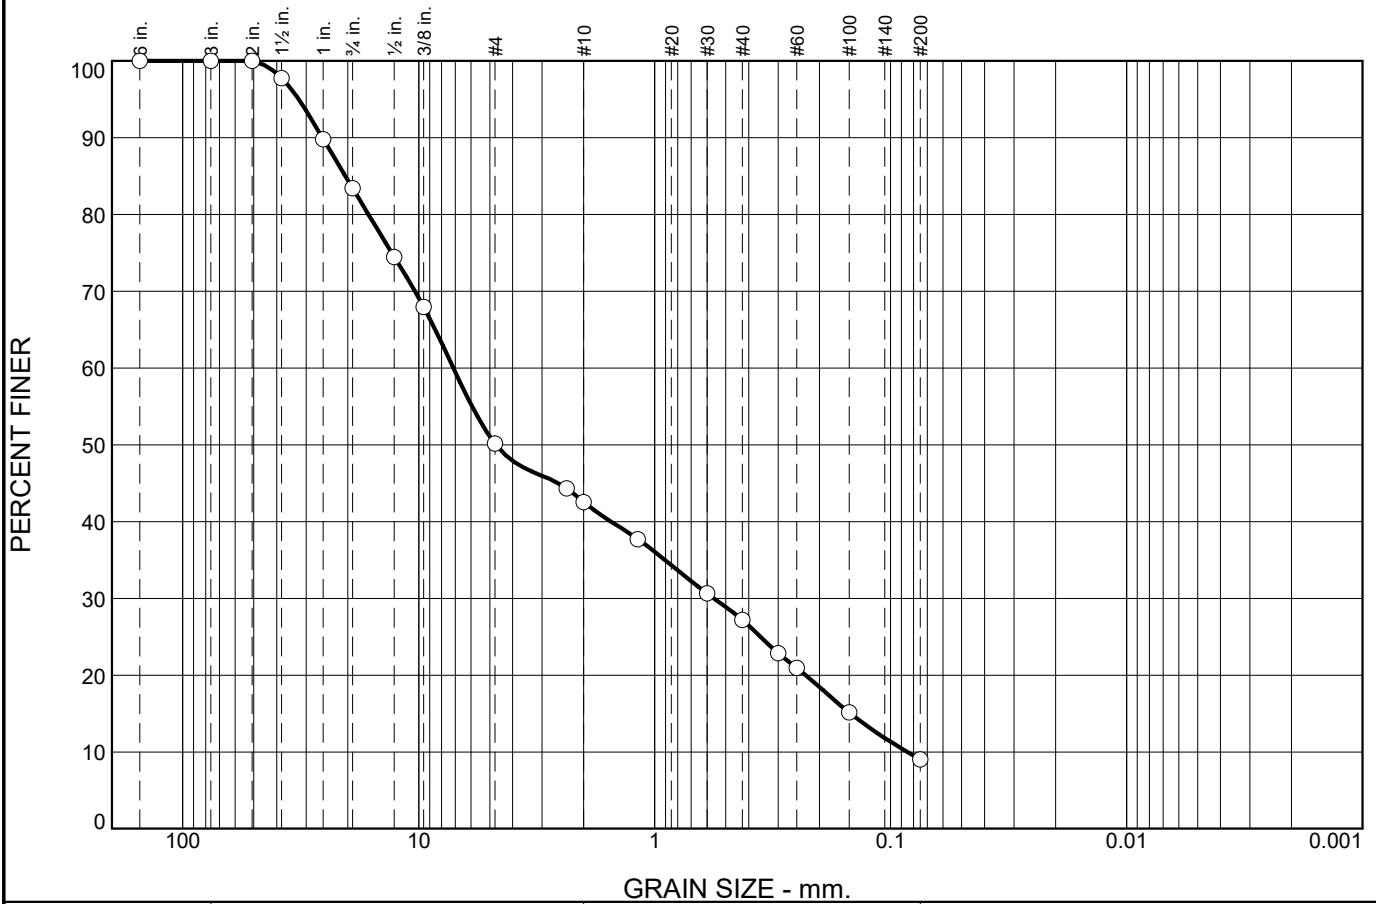
Particle Size Distribution Report

coarse to fine GRAVEL, and coarse to fine Sand, trace Silt

D₉₀= 25.6229 D₈₅= 20.4598 D₆₀= 7.1359
D₅₀= 4.7098 D₃₀= 0.5616 D₁₅= 0.1482
D₁₀= 0.0849 C_u= 84.03 C_c= 0.52

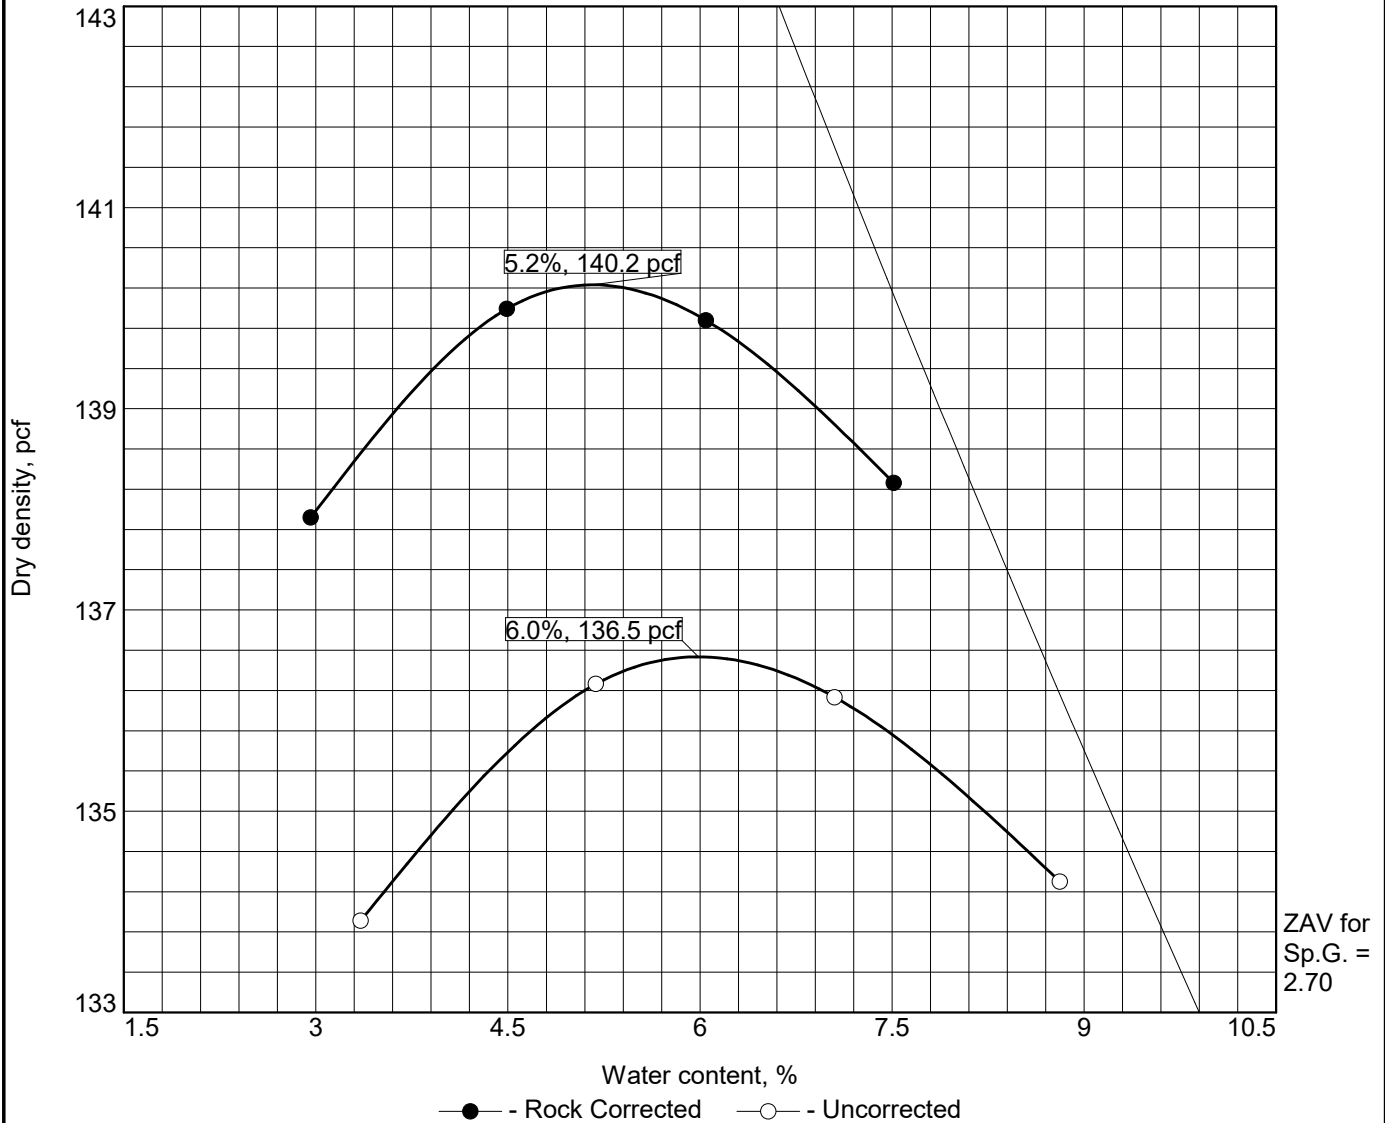
COMPACTION TEST REPORT

ROCK CORRECTED TEST RESULTS	UNCORRECTED	MATERIAL DESCRIPTION
Maximum dry density = 140.2 pcf	136.5 pcf	coarse to fine GRAVEL, and coarse to fine Sand, trace Silt
Optimum moisture = 5.2 %	6.0 %
