Project No.: 21586-01

Date: July 22, 2023

Location: Thompson Landing off Lafayette Road – Rye, NH

FIELD REPORT

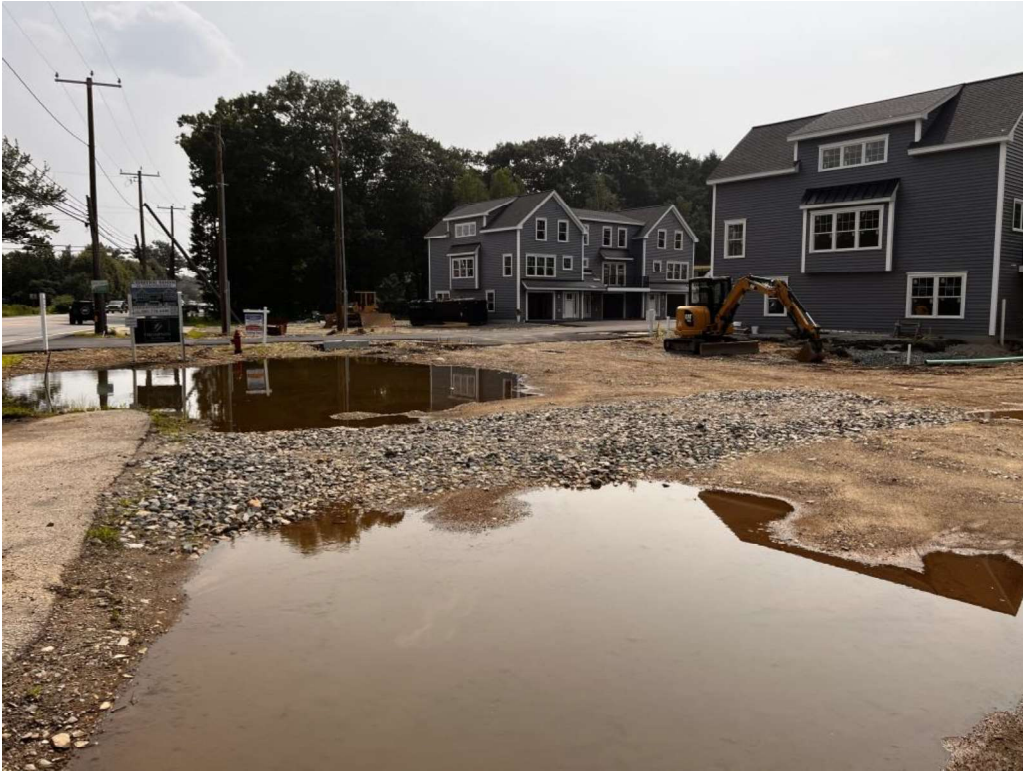
Photo 1 (07-17-23): Overall view of the northerly construction entrance to Lafayette Road. Stone will need to be touched up with stone and monitored during construction. Puddles are from recent rainstorm during the prolonged and ongoing rainy period.

- Stone construction entrances are in place at the temporary route entrances behind the buildings off Lafayette Road. The southerly construction entrance is in good condition and we recommend that the northerly entrance be touched up with stone. Contractor will need to monitor the construction entrance and replenish and replace stone as necessary. These temporary routes are necessary to keep the main accessway porous pavement protected from heavy construction equipment and truck traffic.
- No sediment tracking was noted from the site along Lafayette Road.
- Erosion control silt sock has been added to existing storm drain inlet at the southerly corner of the parcel. This inlet shall continue to be monitored to make sure that sediment buildup is not present.

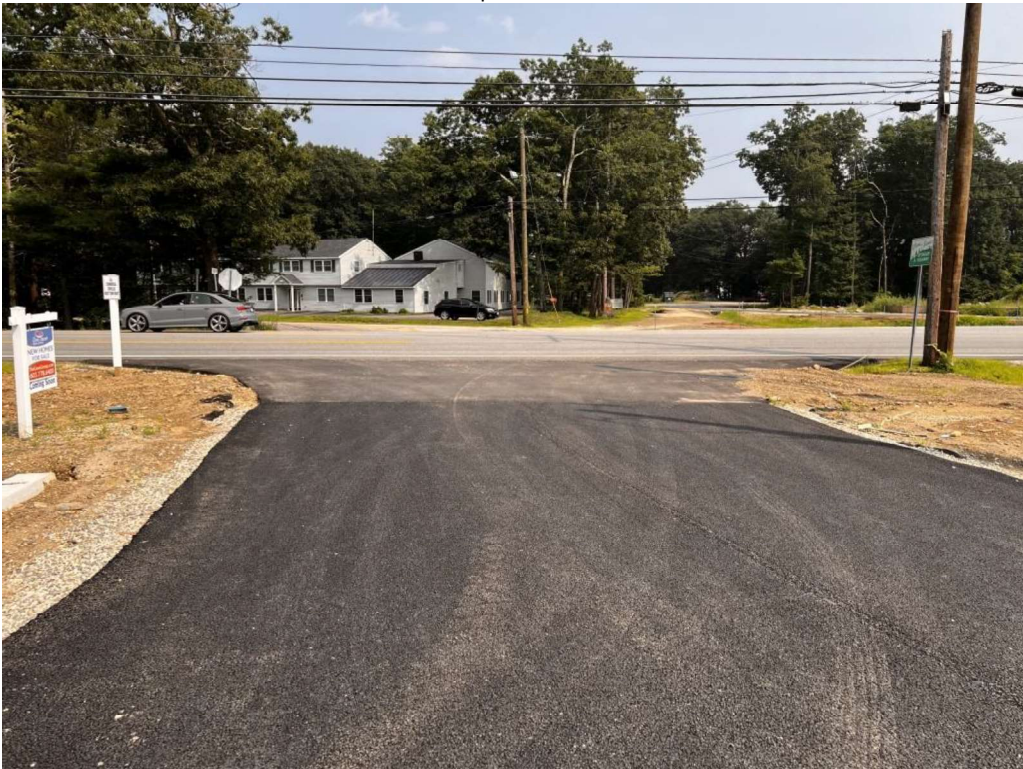
Photo 2 (07-17-23): Main site entrance facing south. No tracking observed on Lafayette Road.

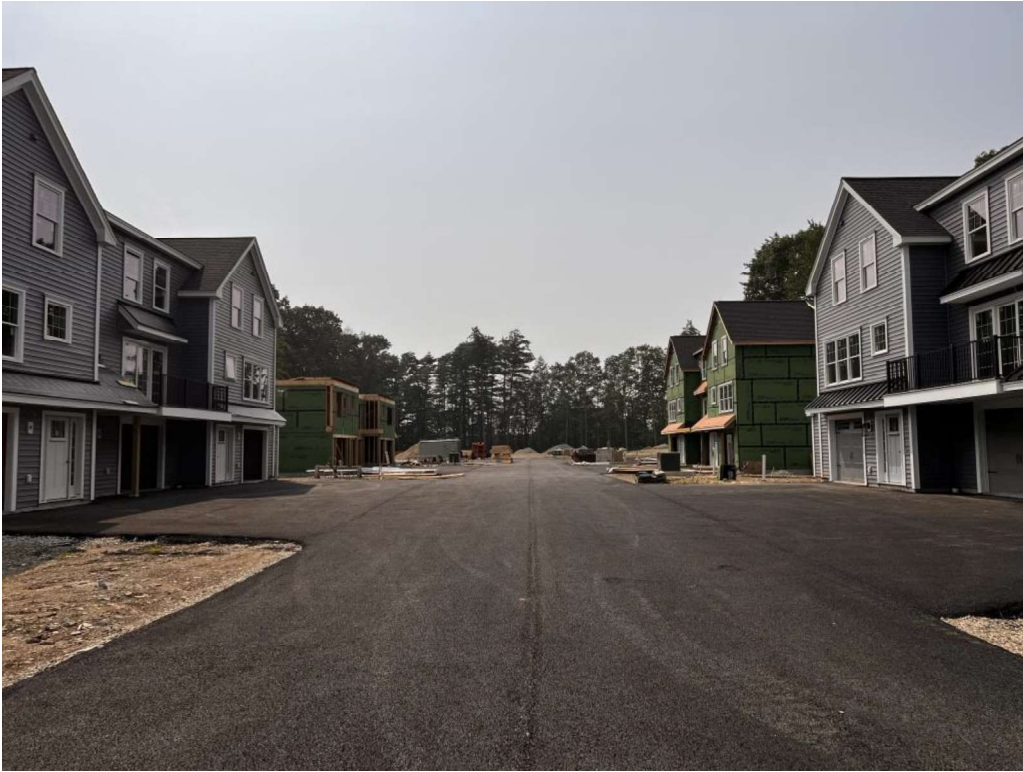
Photo 3 (07-17-23): Main driveway to site with base layer of porous asphalt.

- As noted in previous reports, the contractors will need to take great care in protecting the porous pavement from damage now that it is placed. Truck traffic and equipment that could track detrimental material onto the porous pavement will need to be rigorously discouraged from traveling over the porous pavement surface and must exclusively use the temporary roadways that are in place on the outside edges along the property boundaries.
- The site contractor should advise Sebago of their upcoming schedule of activities so that we can time our site visits to be most efficient and in step with the site's activities.

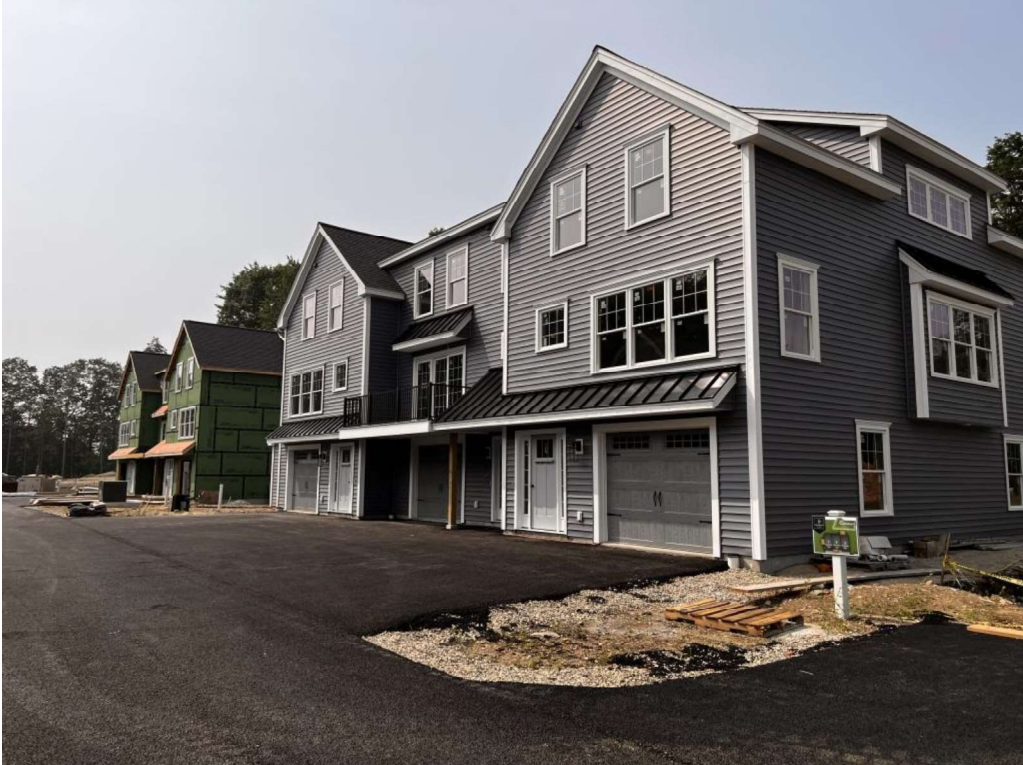
Photo 4 (07-17-23): Southeast side of Building Units 28 to 30 with exterior work complete.

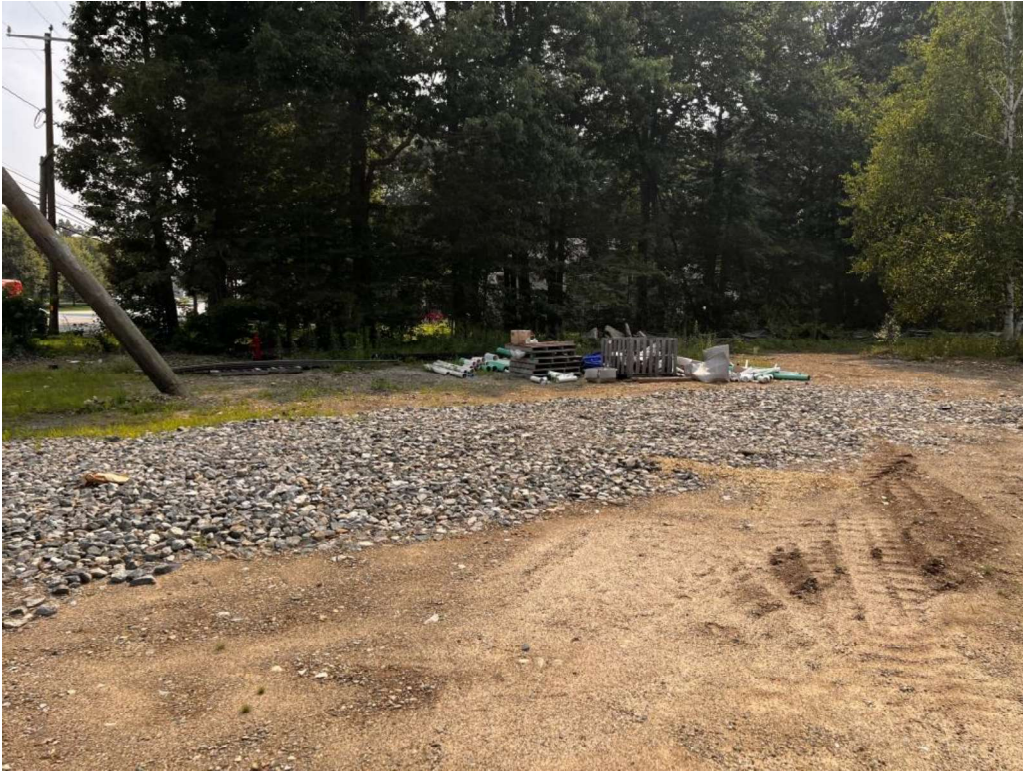
Photo 5 (07-17-23): Stabilized construction entrance placed at the south side of the site with no tracking on Lafayette Road.

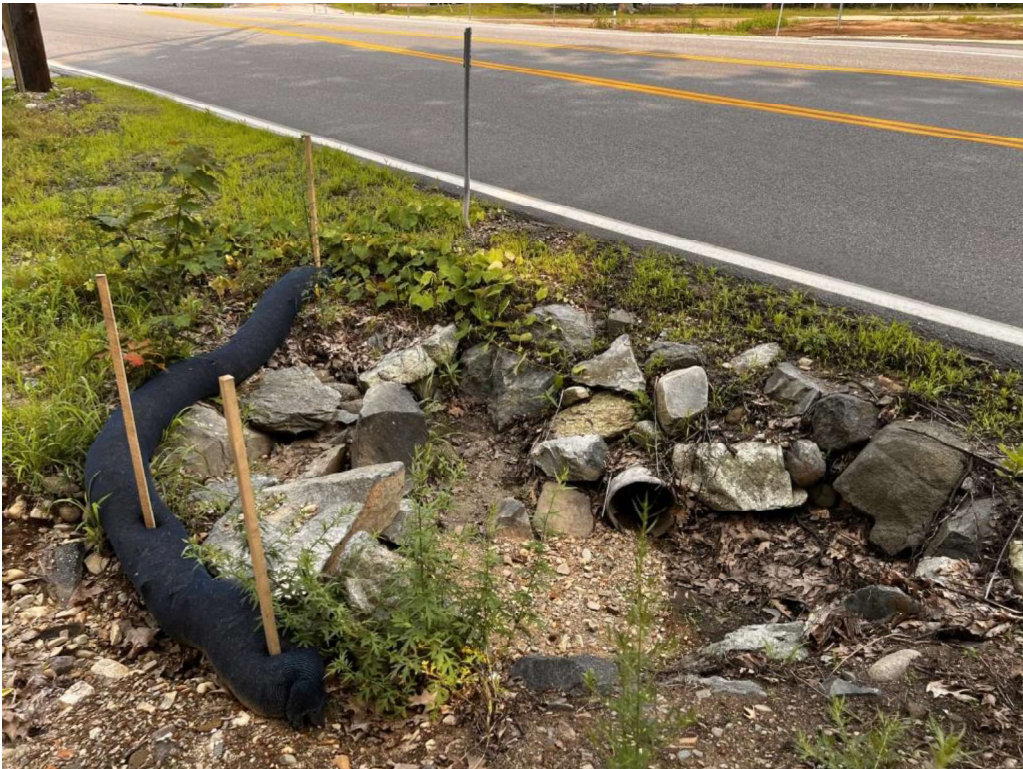
Photo 6 (07-17-23): Lafayette Road cross culvert inlet with erosion control silt sock installed.

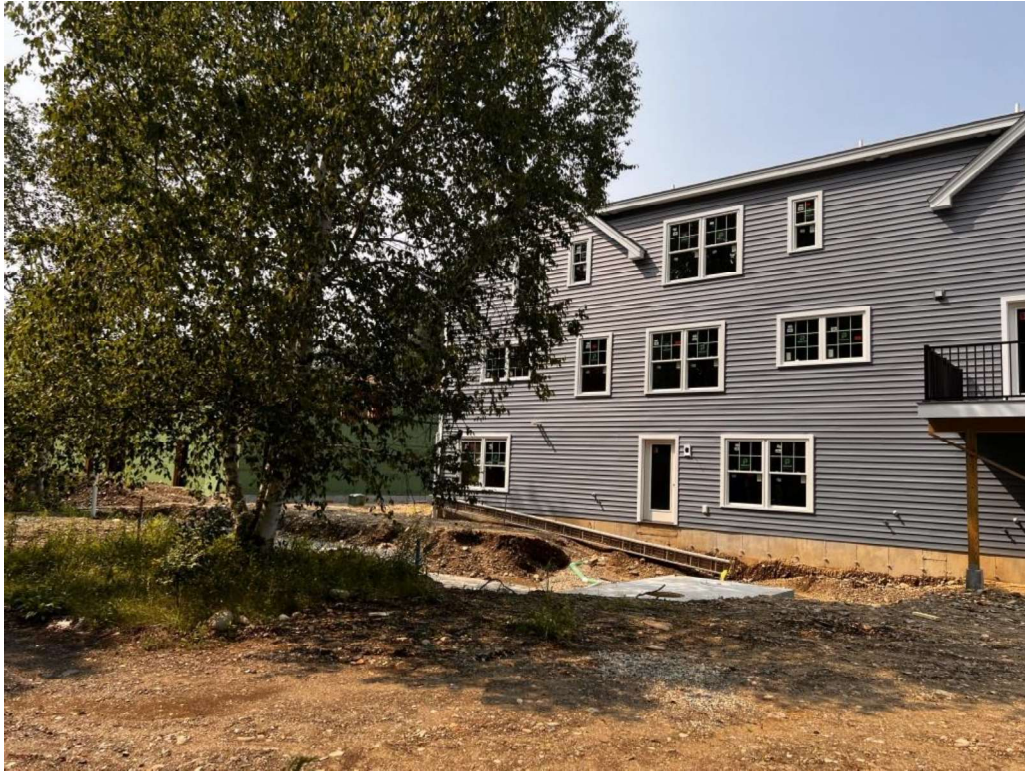
Photo 7 (07-17-23): Overall view of south side of site with constructed Building Units 28 to 30.

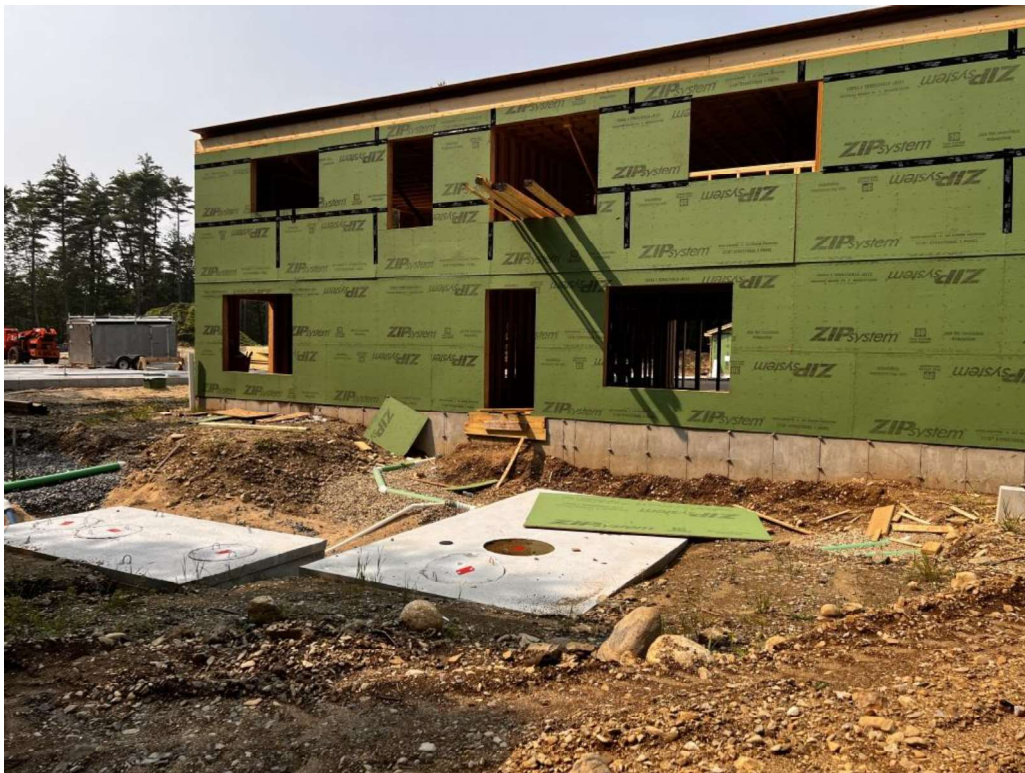
Photo 8 (07-17-23): Overall view of septic tanks installed to the south of Building Units 25 to 27.

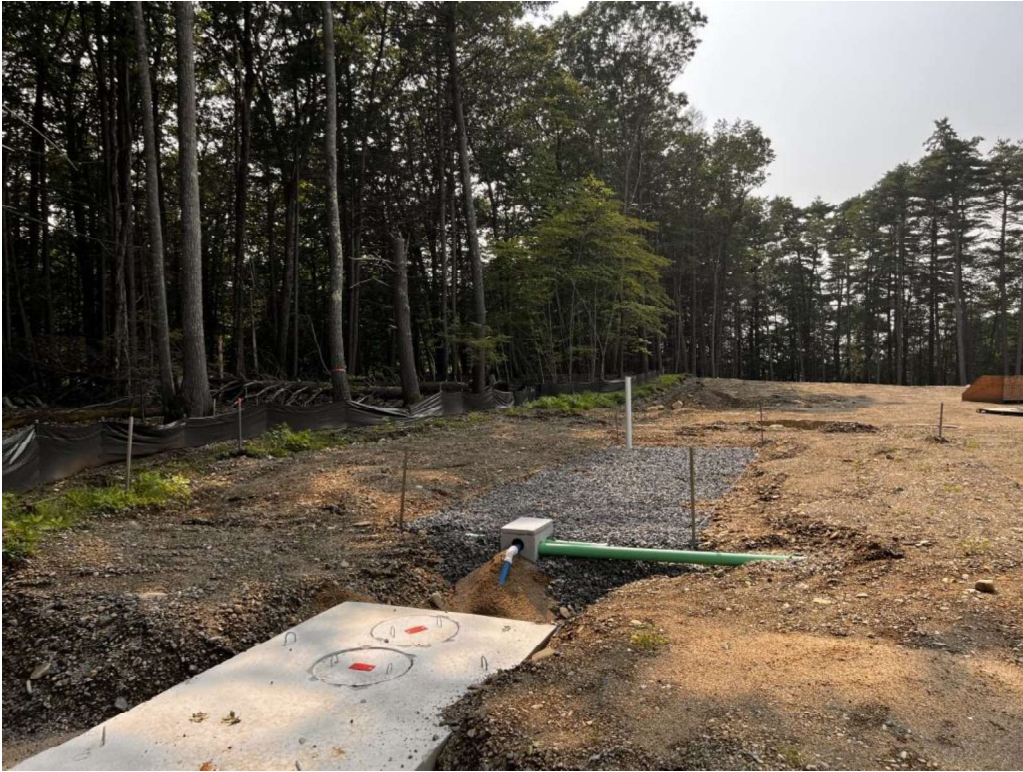
Photo 9 (07-17-23): Constructed septic system for Building Units 22 to 24.

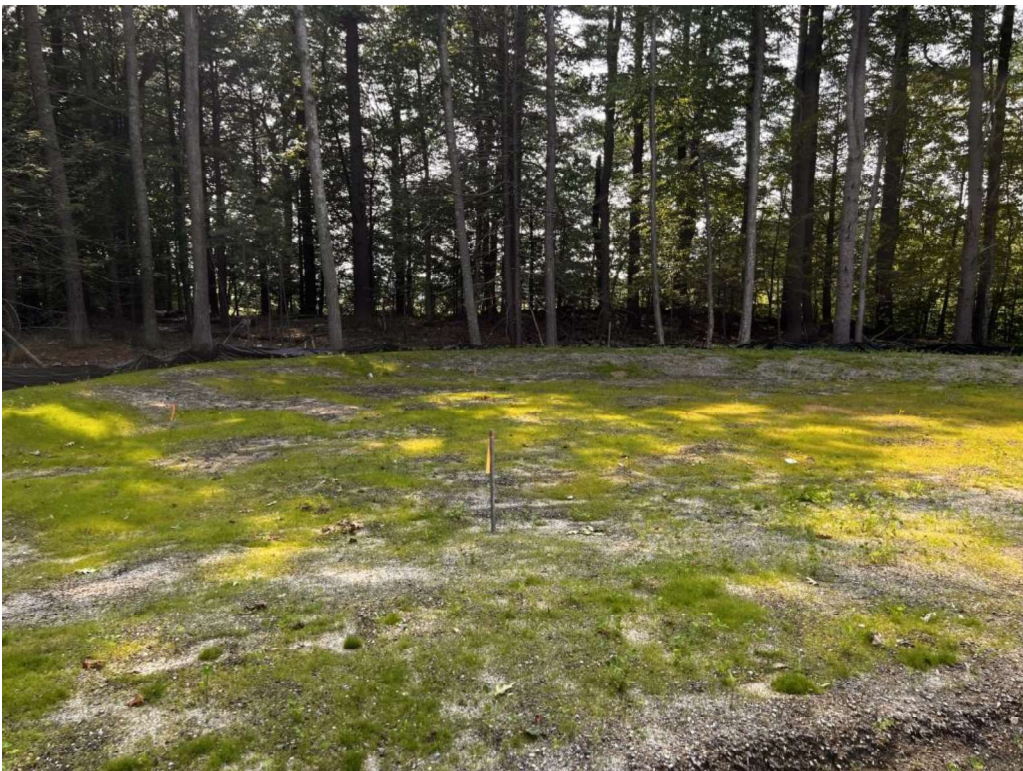
- Sparse growth in infiltration basin will need to be touched up.
- Erosion control filter barrier to be added around the north corner of property line behind stockpile area.

Photo 10 (07-17-23): Constructed infiltration basin sparse grassed area to be touched up.

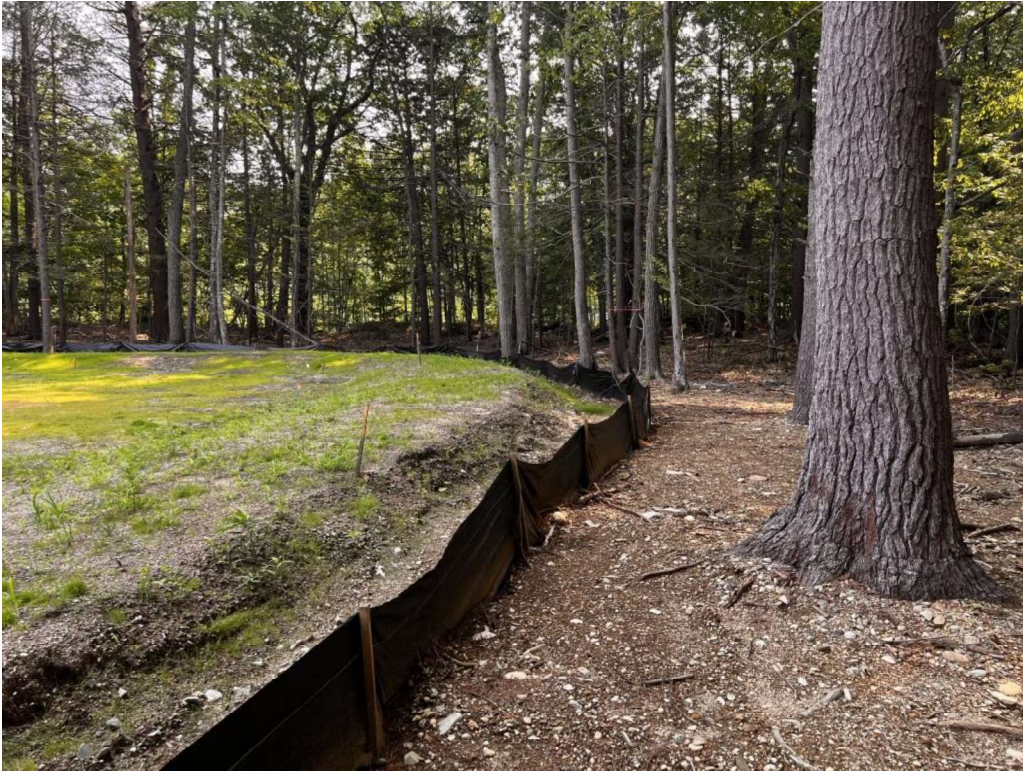
Photo 11 (07-17-23): Erosion control filter barrier has been reinstalled along the westerly property line behind the Grassed Infiltration Basin.

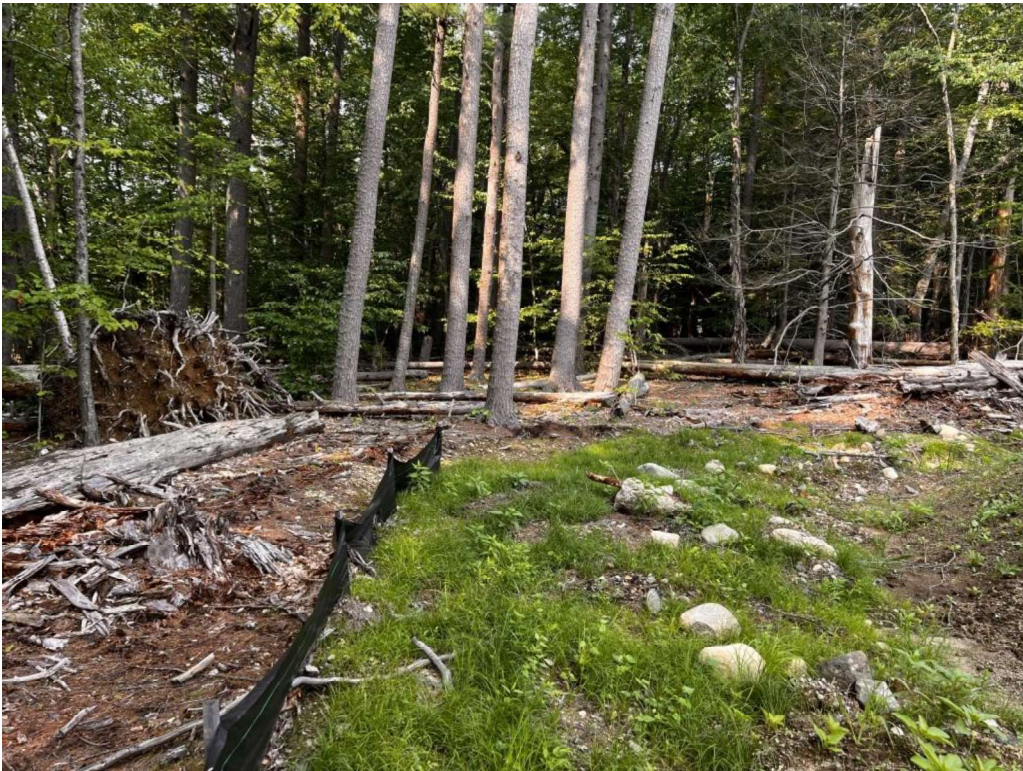
Photo 12 (07-17-23): Erosion control filter barrier to be installed around the north corner of property line behind the stockpile.

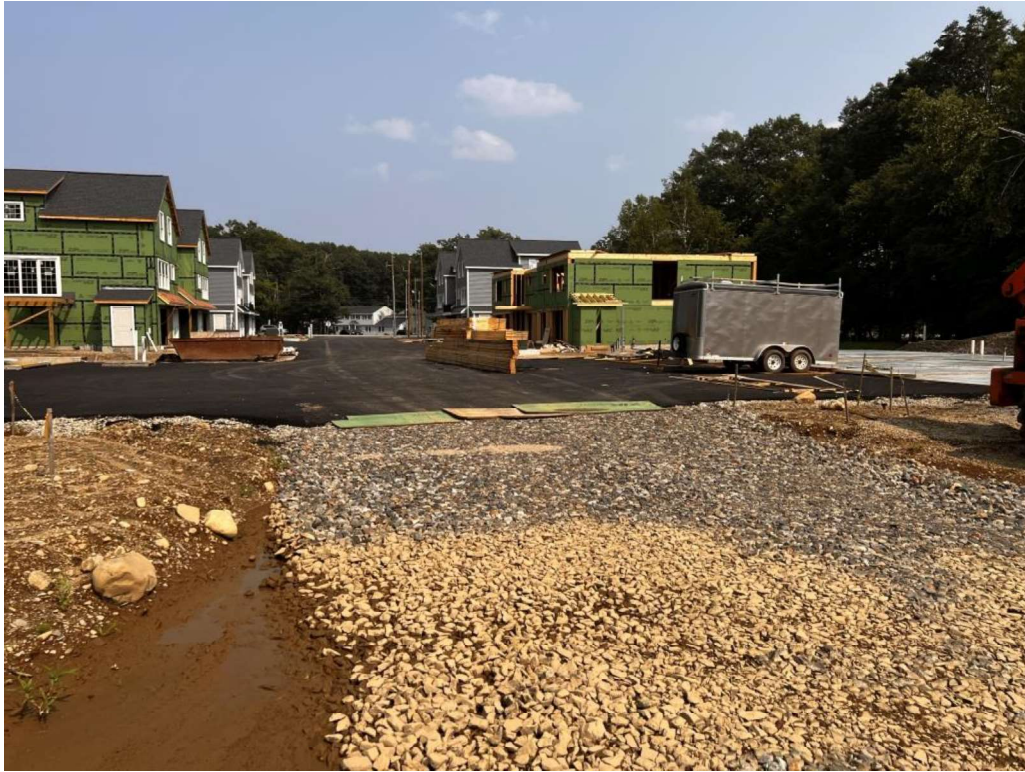
Photo 13 (07-17-23): Stabilized construction entrance on northwest end of main driveway.

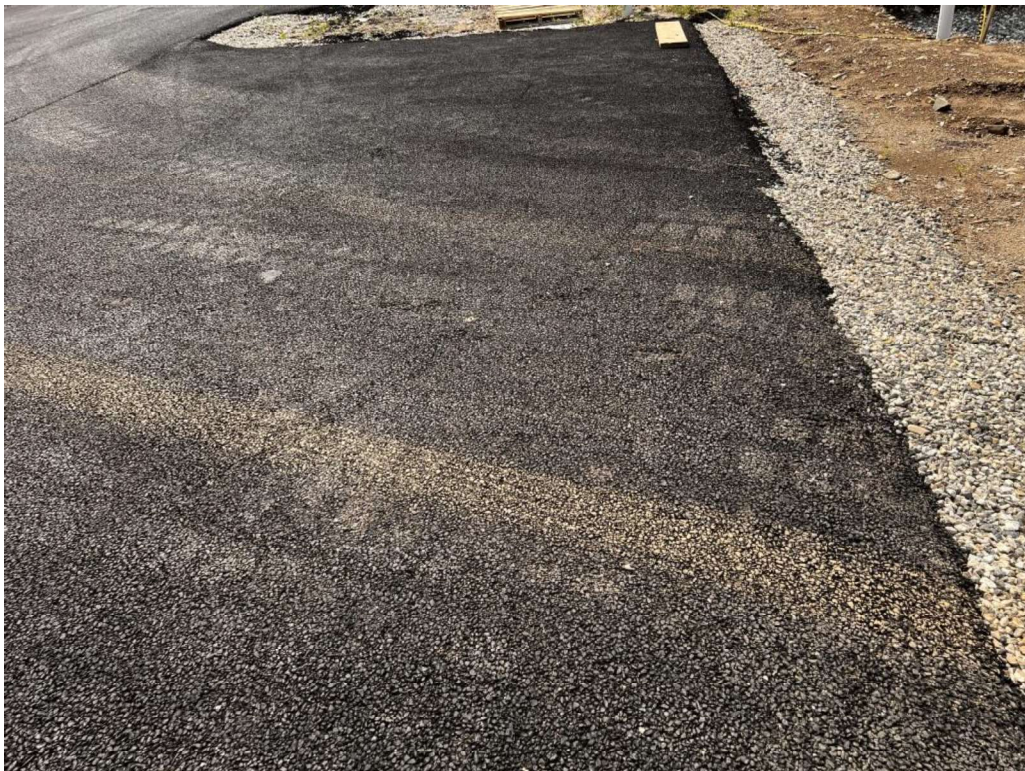
Photo 14 (07-17-23): Tracked sediment from site noted in various locations to be monitored and cleaned up as necessary.

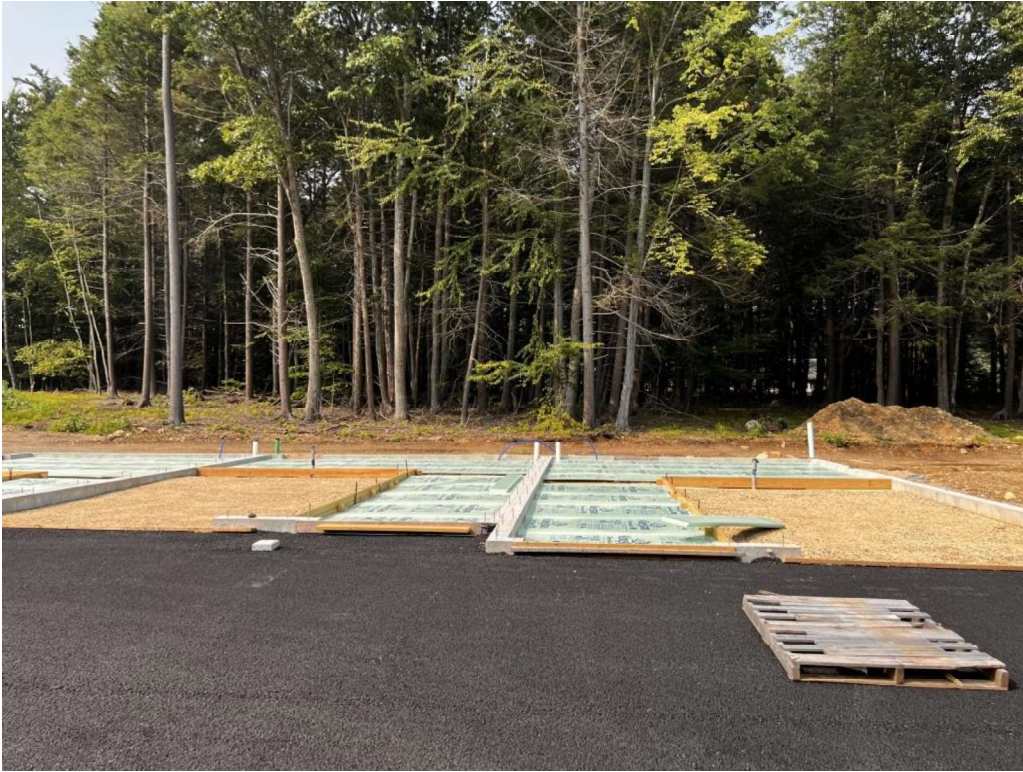
Photo 15 (07-17-23): Installation of foundation slab for Building Units 7 to 9.

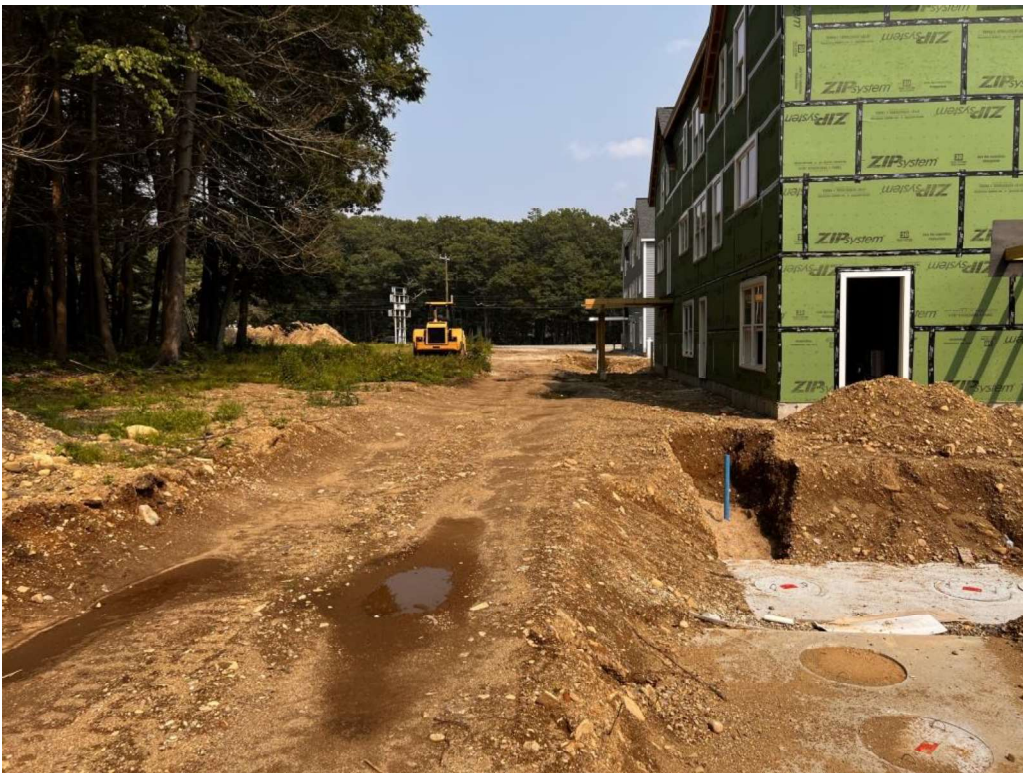
Photo 16 (07-17-23): Temporary construction access road along north side of site in good condition.
