GENERAL PHYSICAL CONDITION ASSESSMENT REPORT

Rye Second Parish Apartments
575 Washington Rd
Rye, NH 03870

Inspection Date: June 3, 2015

Rye Second Parsonage Apartment Facility Evaluation

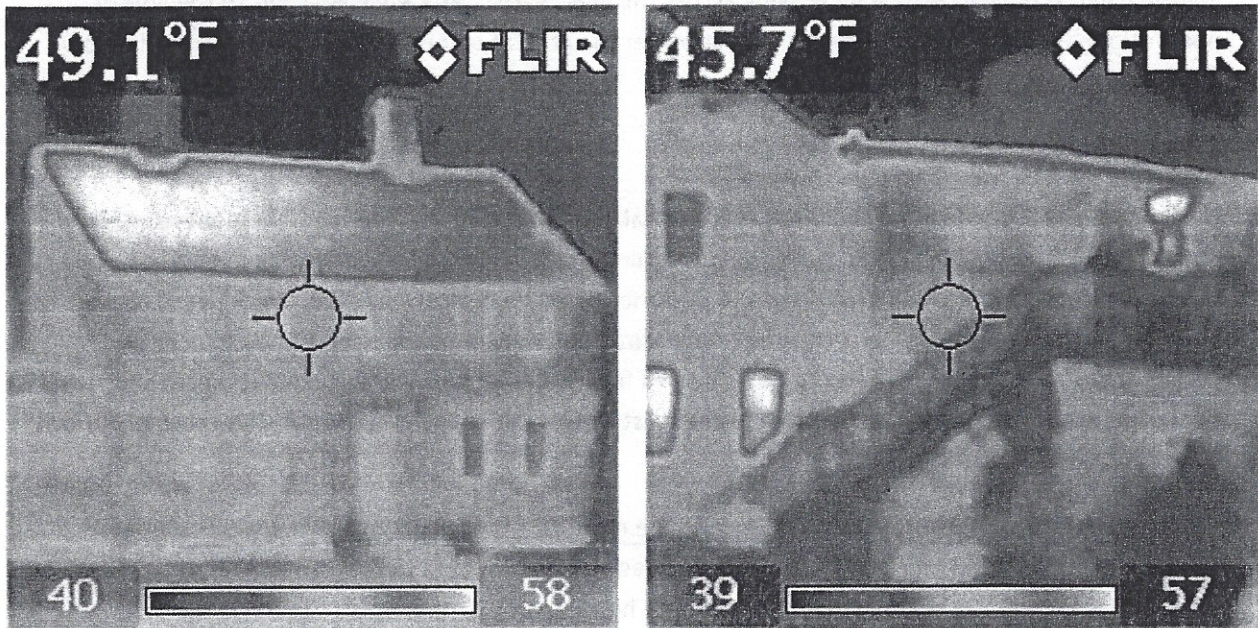
Masonry chimneys have lost mortar and should be repointed to prevent damage to the bricks. The brick masonry at the corners with downspouts also need to be repointed.

The front gutter on the main house is bent off the fascia and should be replaced. The leaders from the front gutter are not attached. Some leaders were clogged with leaves at the time of inspection and should be cleaned. All downspouts need diverters at the base and need splash blocks to prevent damage to the building foundation.

- Gutters, downspouts and splash blocks need to be addressed. The gutter on the front of the main house needs replacing. Downspouts need to be secured to gutters where they have pulled away. Downspouts also need to be cleaned of debris that is clogging them. Diverters need to be installed at the base of the downspouts to direct water away from damaging the foundation and splash blocks need to be installed to carry water away from the house.
